# Development Application

**Environmental Impact Assessment**  
**687 Ardmore Road – District of North Saanich, BC**

**Re: Geotechnical Assessment of Proposed Foreshore Erosion Protection  
Located at 687 Ardmore Drive, North Saanich, BC**

**MORTARED ROCK RETAINING WALLS**  
687 ARDMORE DRIVE, N. SAANICH

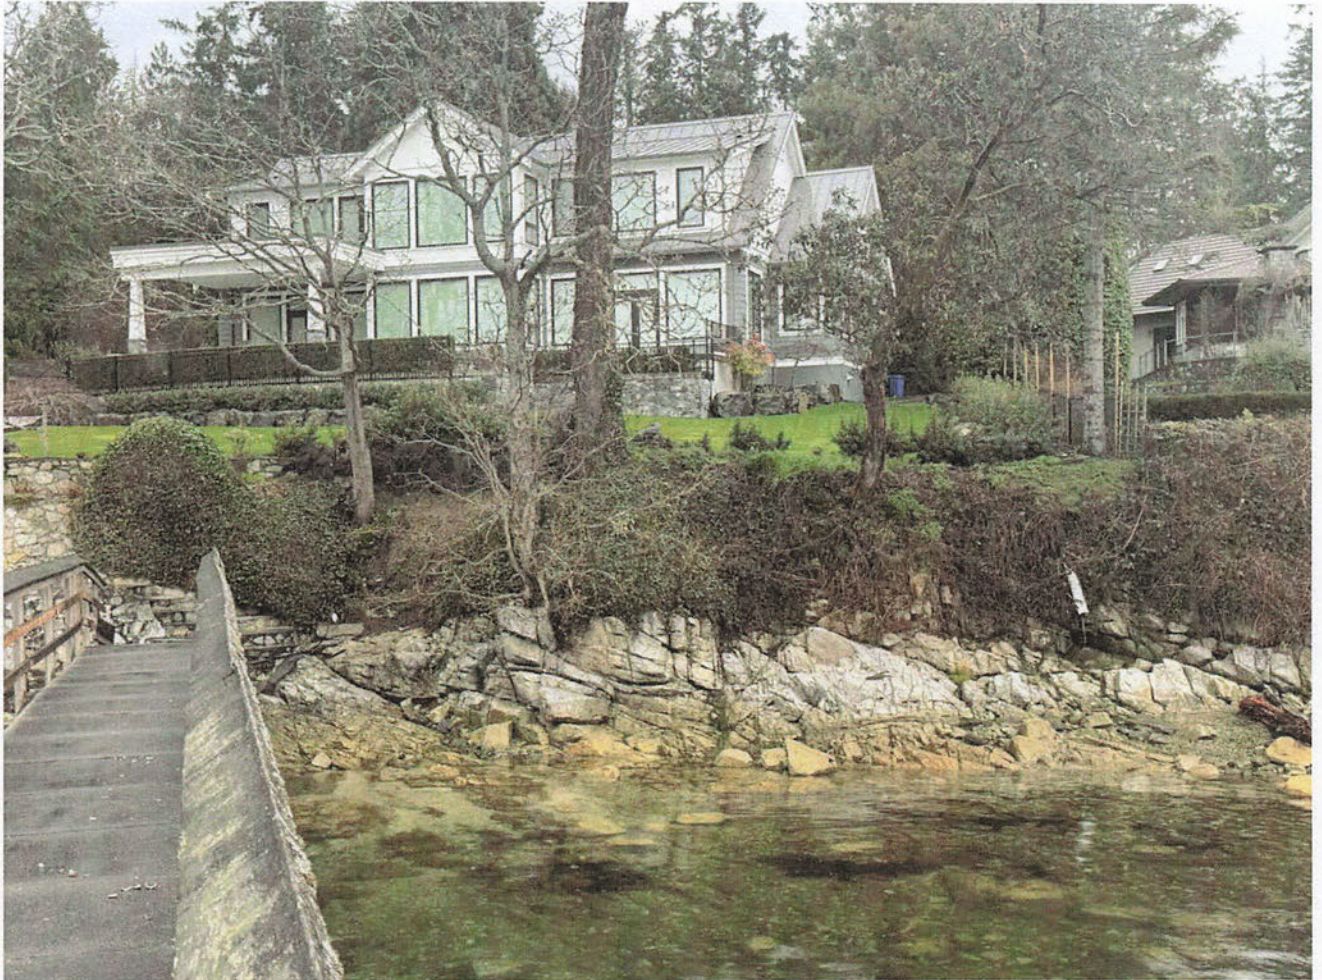
Plate #1. View of existing conditions within the 15m marine DPA

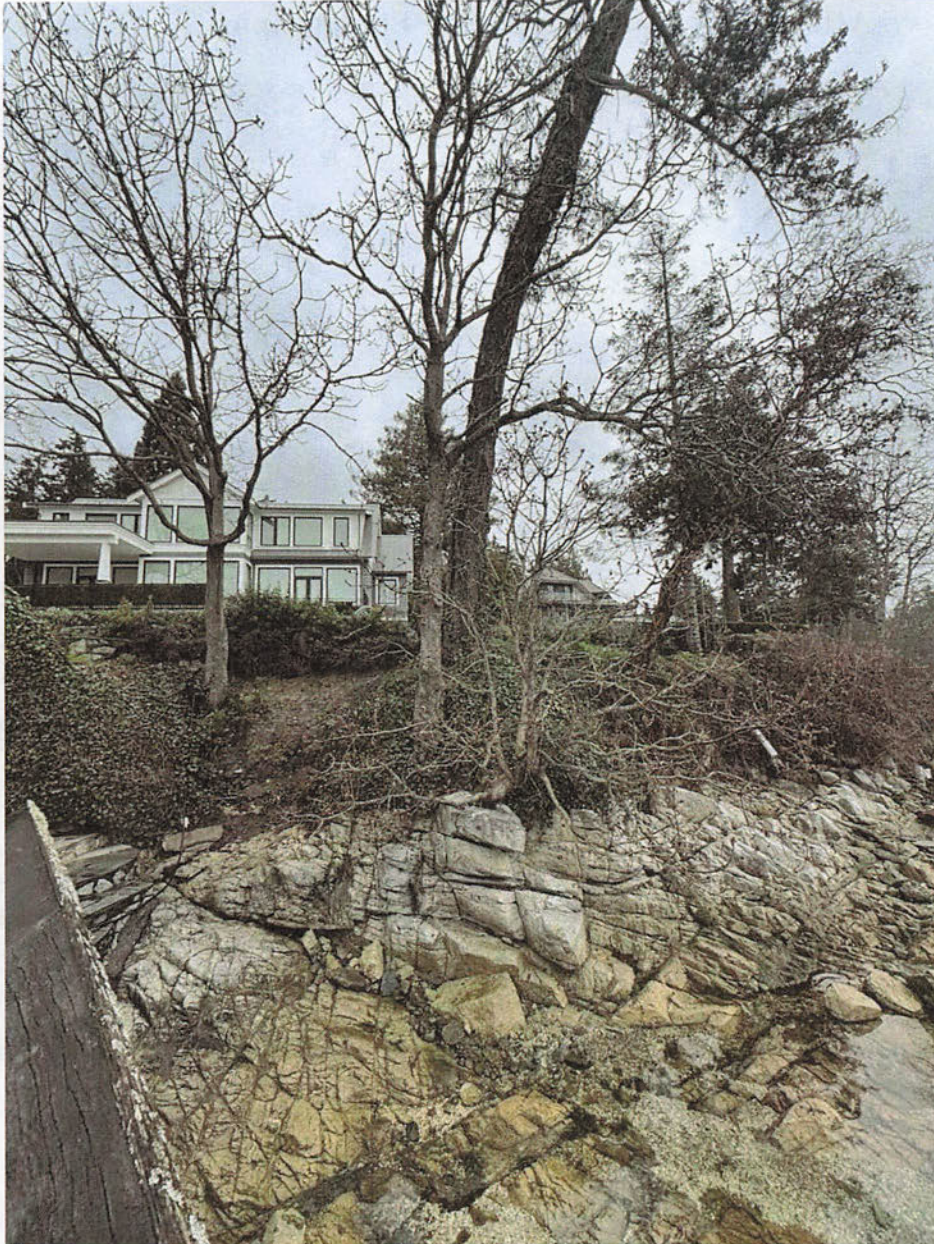
Plate #2. Typical view of existing conditions along the 15m marine DPA and the proposed retaining wall area. Works are proposed above the exposed bedrock

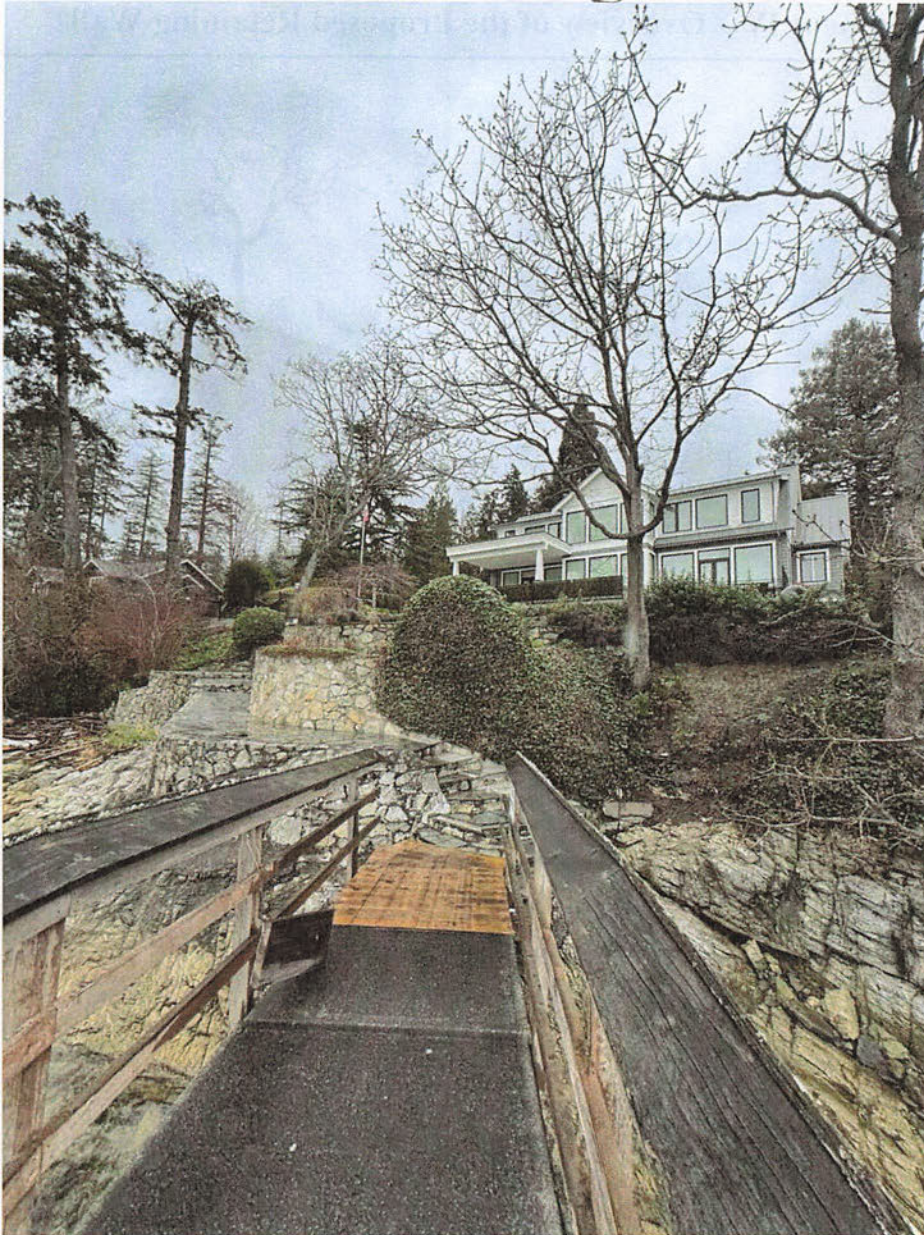
Plate #3. Typical view of existing conditions along the 15m marine DPA and the proposed retaining wall area. Works are proposed above the exposed bedrock

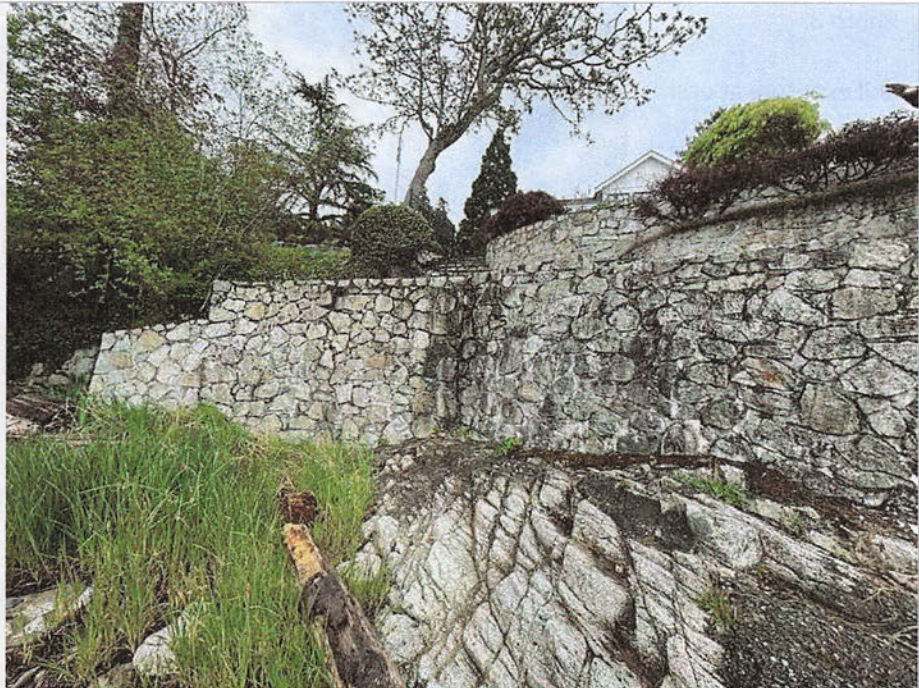
Photo 1:

View of existing mortared rock wall at the west side of foreshore slope.

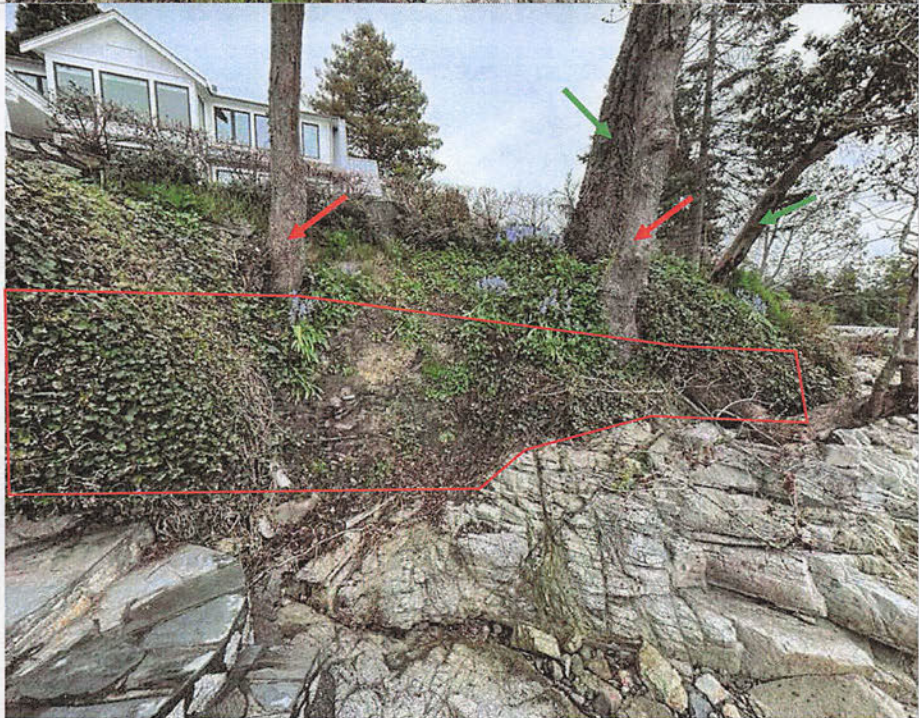
Photo 2:

- **Vegetation and Erosion Impact:** Several mature trees along the crest of the slope show exposed root systems due to soil erosion on the west side, although they remain healthy despite a noticeable lean towards the slope. The trees near the crest of slope consist of grand fir, arbutus, and pine. This erosion threatens the stability of the trees and could lead to further degradation and regression of this area if the trees are lost.

Soil exposure at mid-east section of slope.

Red outline shows where wall could be constructed atop bedrock to retain / protect the slope.

Trees to be removed marked in red.  
Retained in green.

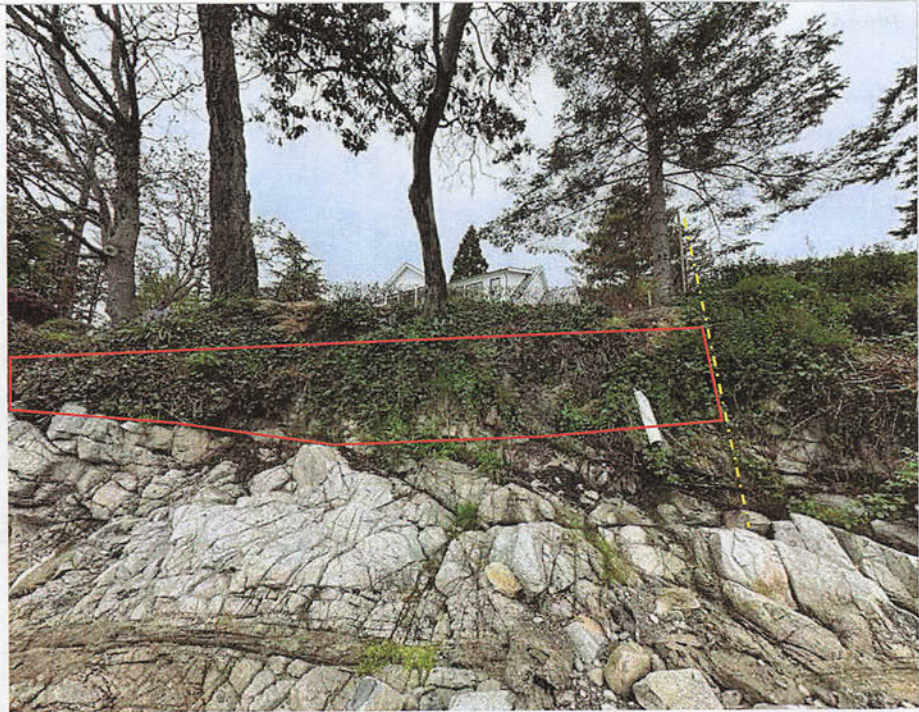
Photo 3:

Soil exposure at east section of slope.

Red outline shows where wall could be constructed atop bedrock to retain / protect the slope.

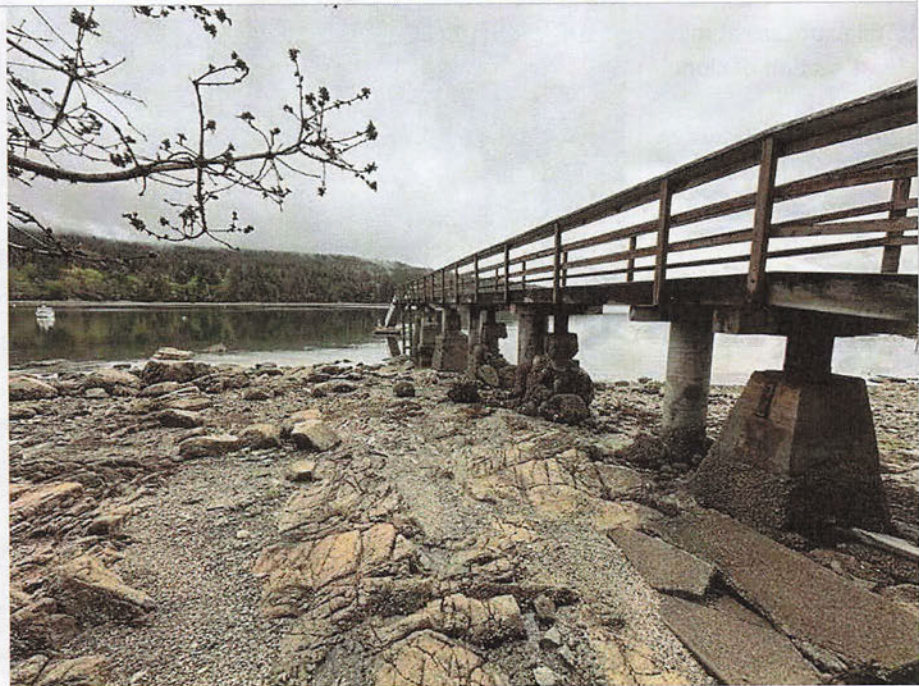
Photo 4:

View of rock beach and existing pier.
