# Development Application

## District of North Saanich

Civic Address 916 LANDS END ROAD PID 032-551-916

This technical addendum accompanies the architectural and landscape drawings submitted under the Development Permit application. The purpose of this document is to summarize the ecological function, shoreline protection measures, habitat performance and enhancement, and ecosystem service contributions of the proposed native planting plan within a designated Shoreline Development Permit Area. This project proposes new stairs from an upper terrace leading to the lower lawn terrace and the beach. A replacement fence, replacing a dilapidated wooden fence, will provide a safe, security railing at the top-of-bank, the existing patio will be moved laterally to minimize noise for the neighbour, the replacement planting will enhance the natural, riparian food web and habitat, historical rotting fences along the north, east, and west property borders will be replaced to secure the property for the owner's dogs, and the remedial landscape works will protect the shoreline habitat.

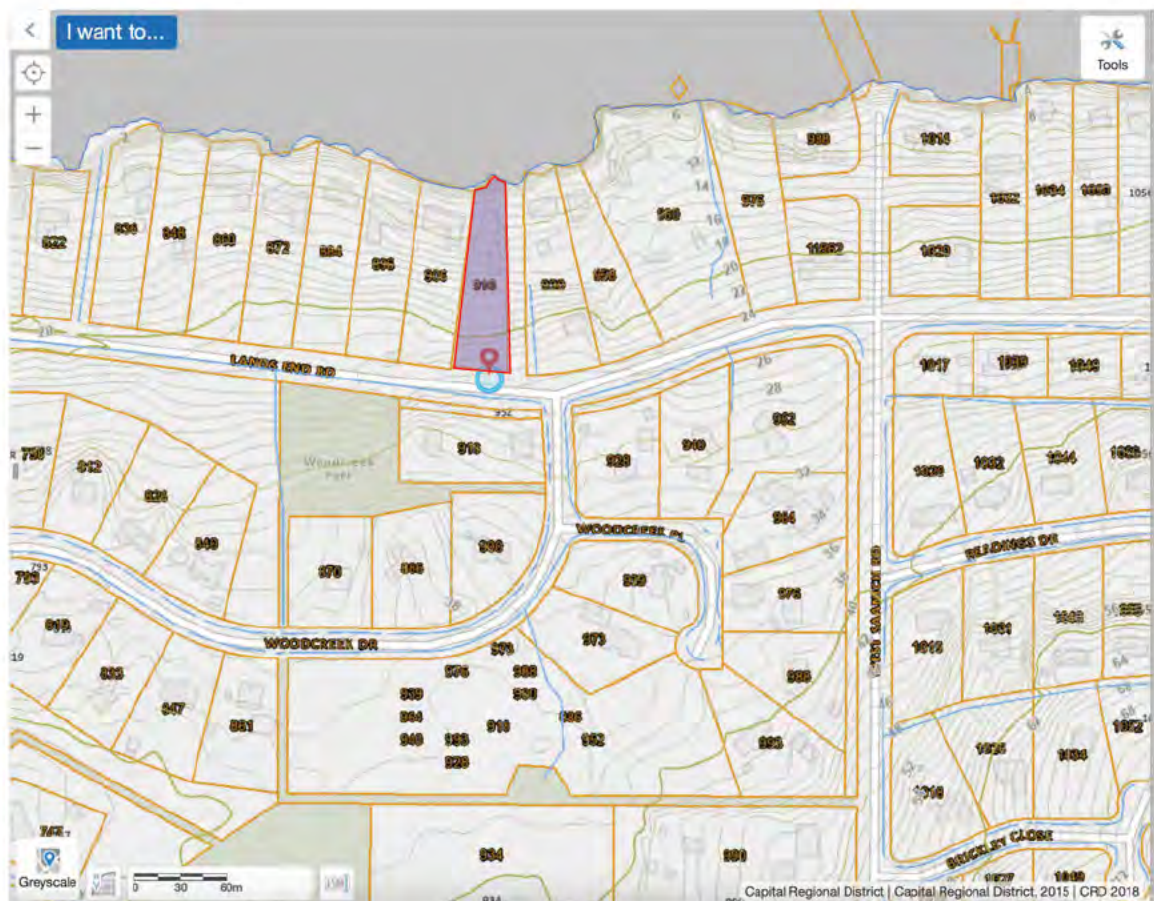
Figure 1. The property is highlighted as an orange polygon. Note the narrow municipal shoreline access east of the property. This shoreline access trail includes stairs to the upper intertidal and a municipal drainage channel, portions of which, in the lower reach, as enclosed in a CSP culvert (Figure 2).

The subject property (Figure 1) lies adjacent to Satellite Channel having a narrow shoreline at the northern end of the property. The District of North Saanich's OCP Bylaw No. 1587 (2025) mandates marine shoreline areas are subject to the DPA1-Marine Uplands and Foreshore, whose Guidelines identify the shoreline's high wildlife values and scenic beauty. As documented below, the property does not lie within the DPA2, DPA3, DPA4 areas.

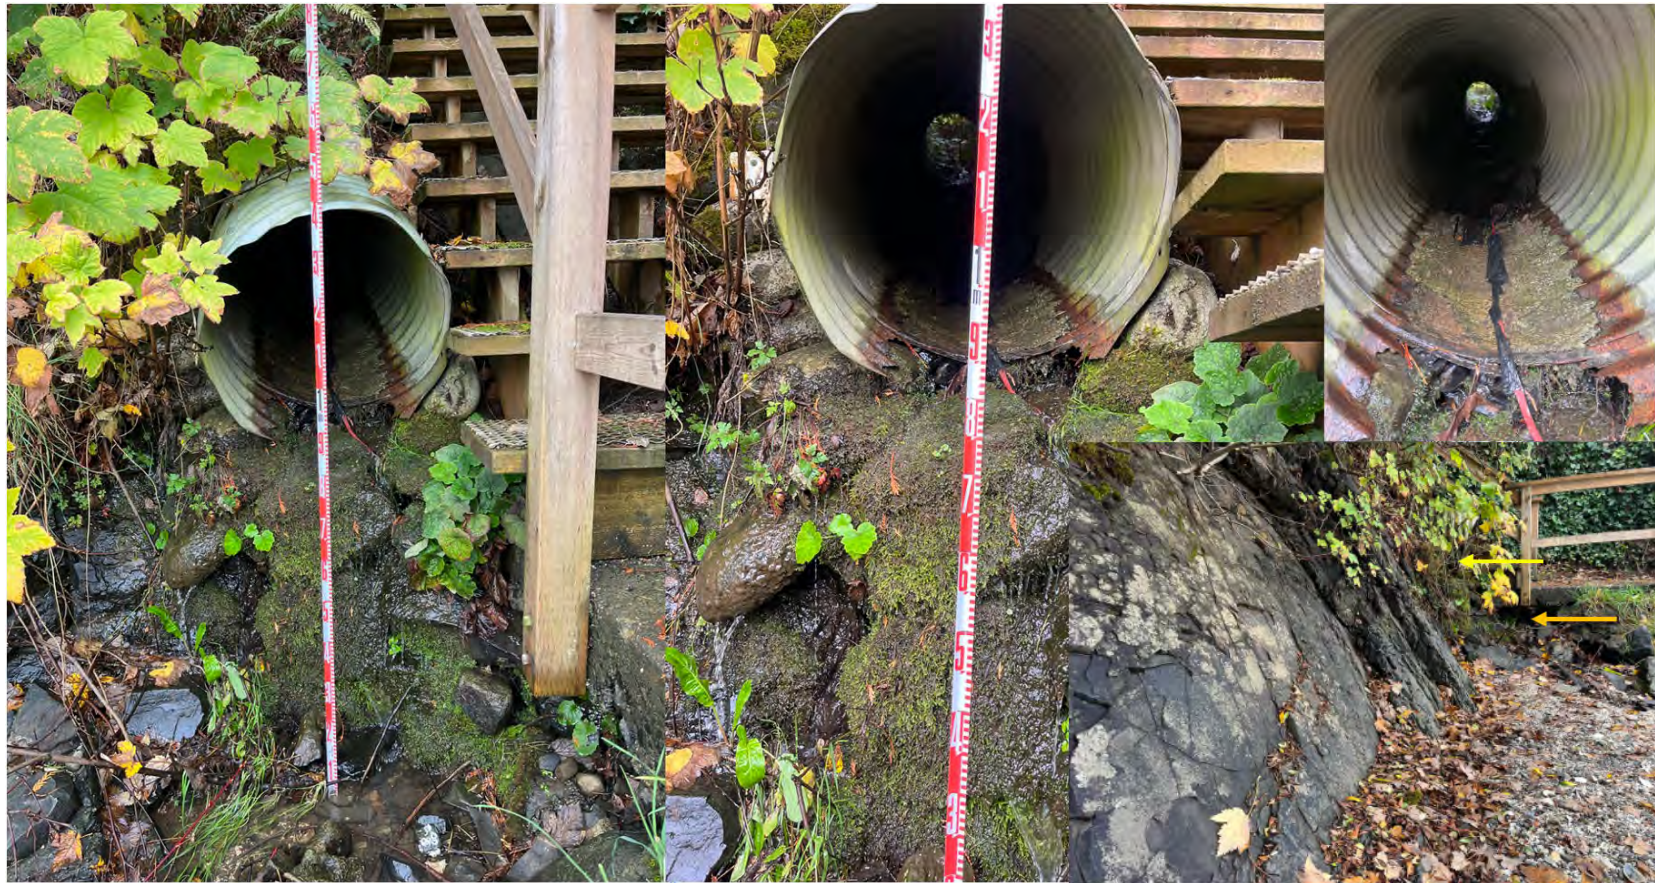
Figure 2. Discharge end of CSP culvert in the municipal shoreline access trail. The CSP culvert has disintegrated in the lower segment, with stormwater discharge flowing under the culvert (inset images on right hand side of figure). The invert of the culvert's discharge is 0.9 m above the upper intertidal shoreline. The High Water Mark of the shoreline (orange arrow) lies below the culvert's invert (yellow arrow). The culvert has a slope of ~35%. This culvert discharges directly onto the marine shoreline's upper intertidal. Thus, it is the opinion of the authors that this drainage ditch is not subject to the RAPR or the *Water Sustainability Act*. Note the municipal public access, wooden stairs leading to the shoreline (far right hand side of photograph).

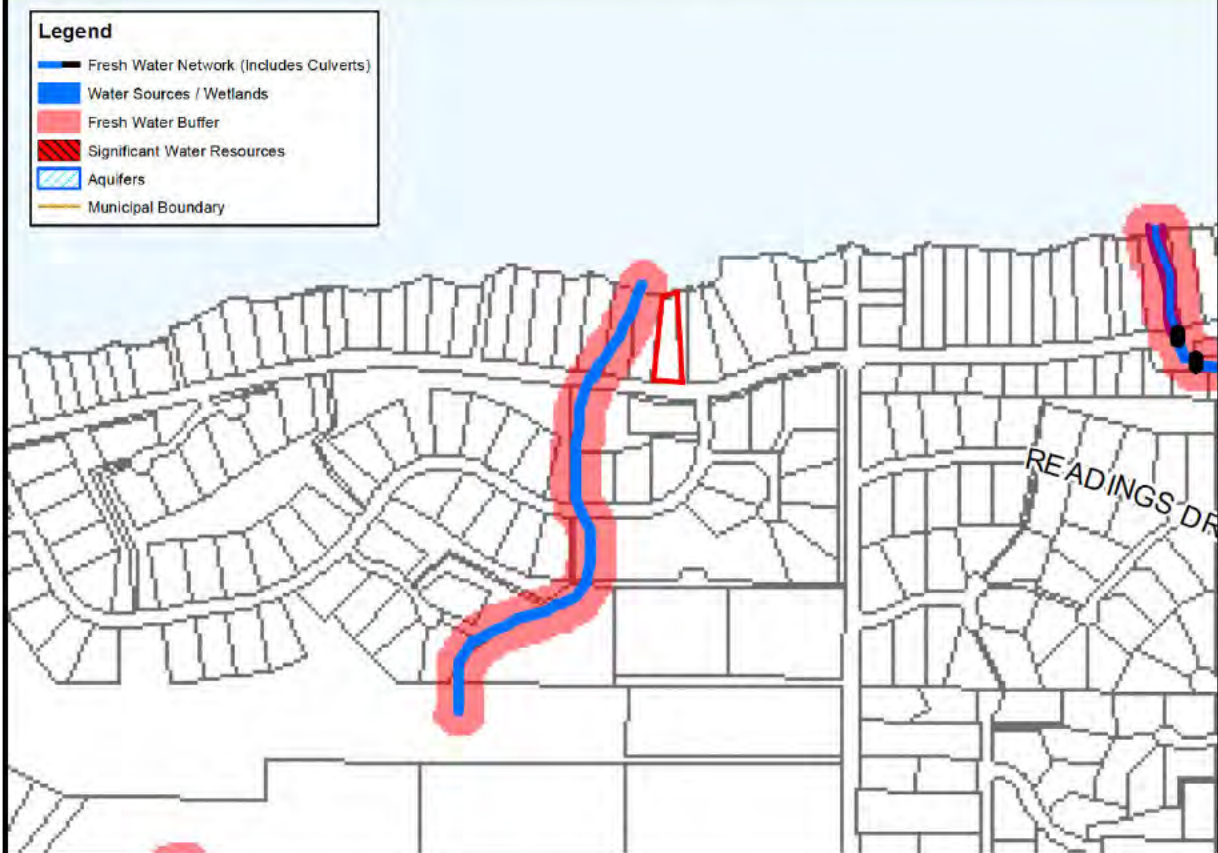
Figure 3. The District of North Saanich's DPA2 indicates a stream to the west of the subject property; the stream location is at the west edge of the adjacent property, a distance of 30 m from the west boundary of the subject property. However, an inspection of the adjacent shoreline did not reveal any stream flowing onto the shoreline as indicated in the DPA2 map (Figure 7).

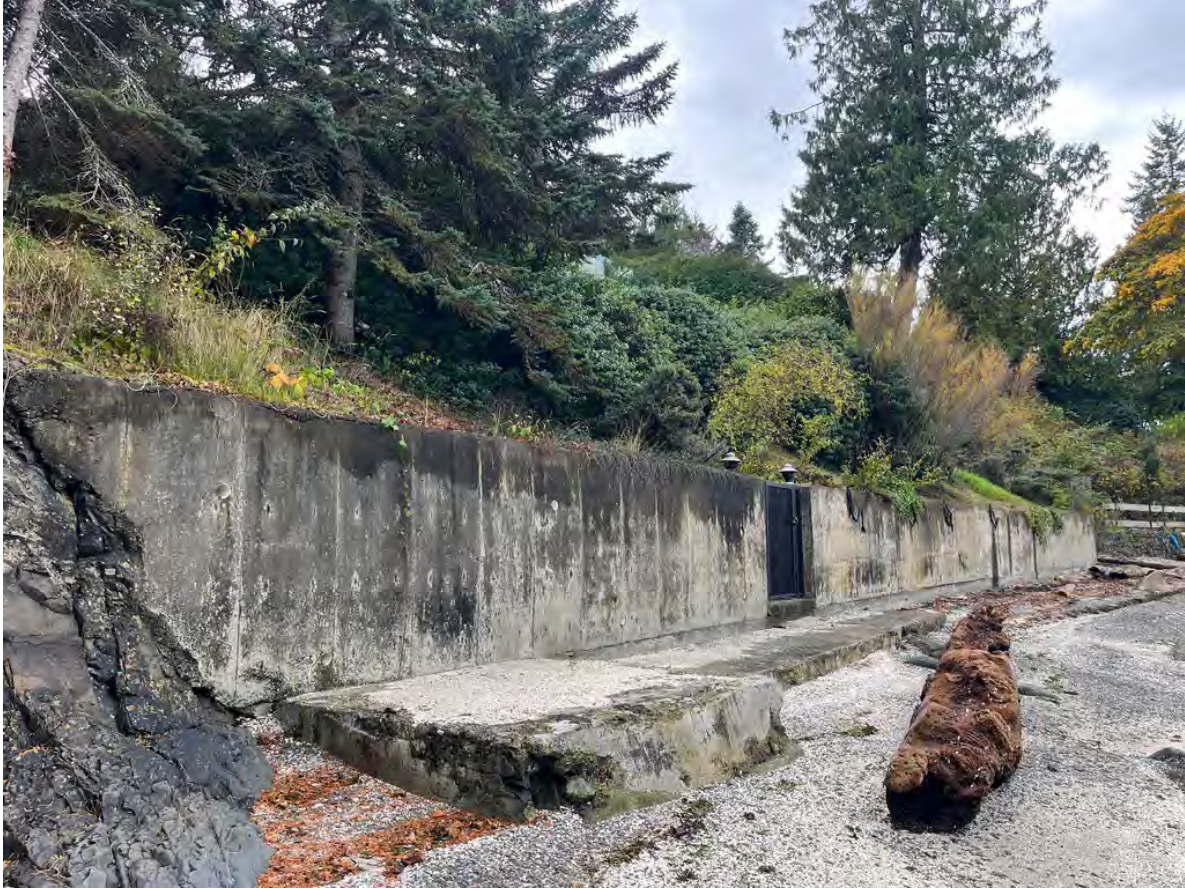
Figure 7. The adjacent property (906 Land's End Road) to the west of the subject property has a concrete retaining wall (~30 m in length), with a concrete toe extending into the upper edge of the intertidal zone. There is a gate (black structure) mid-way along the wall providing access to the shoreline. The next property to the west of 906 also has a mortared stone retaining wall (896 Land's End Road). These retaining walls were installed to prevent shoreline erosion of the riparian soils, lying behind the walls. There was no visible evidence of a stream discharging onto the shoreline on either 906 or 896 Land's End Road properties.

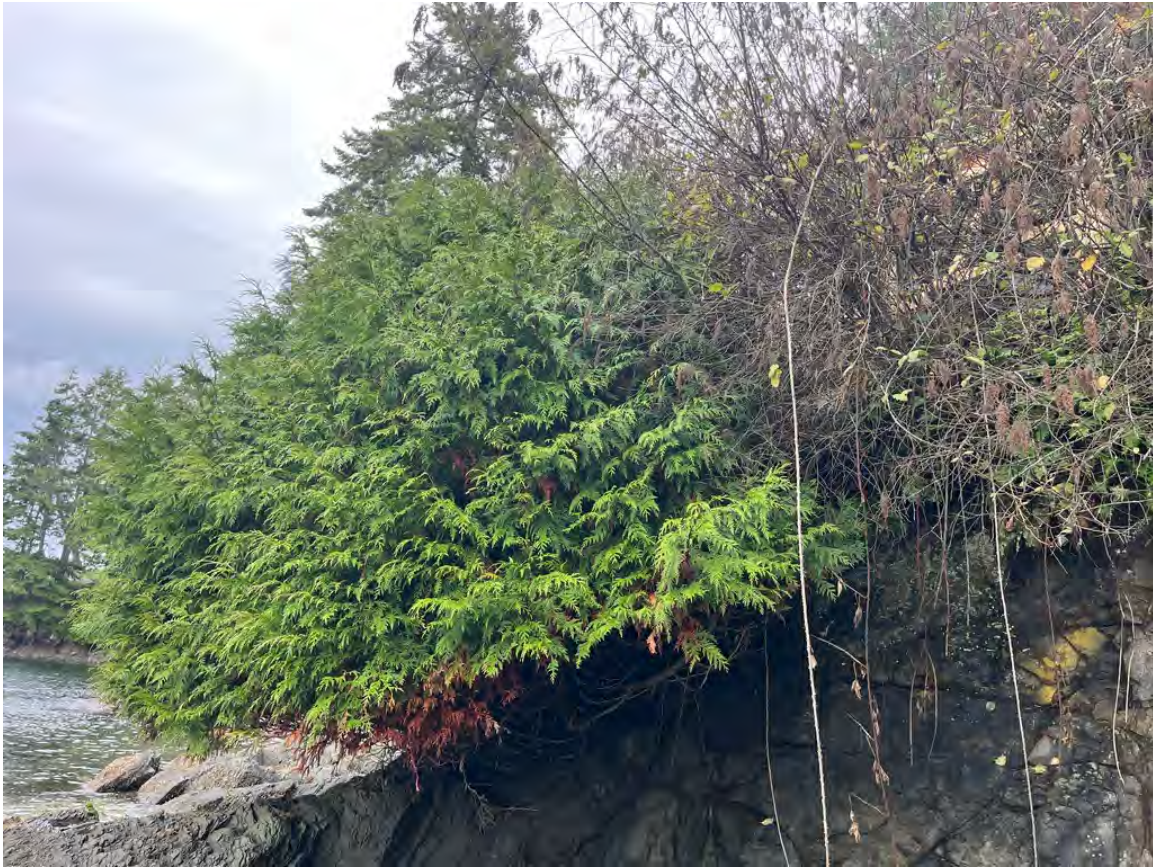
Figure 8. Looking east along the shoreline at the High Water mark / Present Natural Boundary. Note the western red cedar tree growing on the steep slope, the shrub understory, and the bedrock parent material extending into seaward. The area in this photograph is the tip of the small point of land at the northern end of the property.

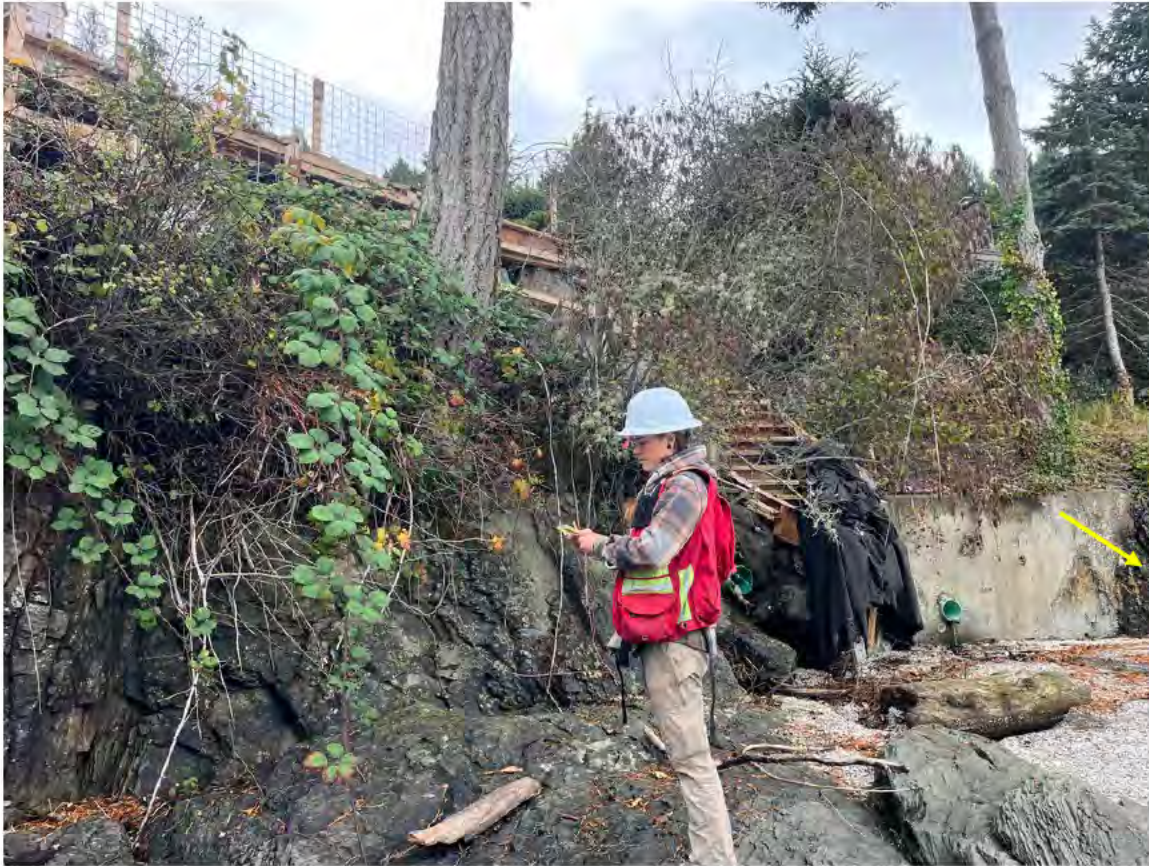
Figure 9. Looking southwest to the stairway that will provide access to the shoreline. Note the Douglas-fir and the invasive blackberry. The bedrock underlying the property extends out into the ocean. The adjacent property's concrete retaining wall extends to the west property boundary of the subject property (compare with Figure 7 which shows the bedrock knoll – yellow arrow). The shoreline, consisting of exposed bedrock, is stable, with a plant community that trails down the steep slope.

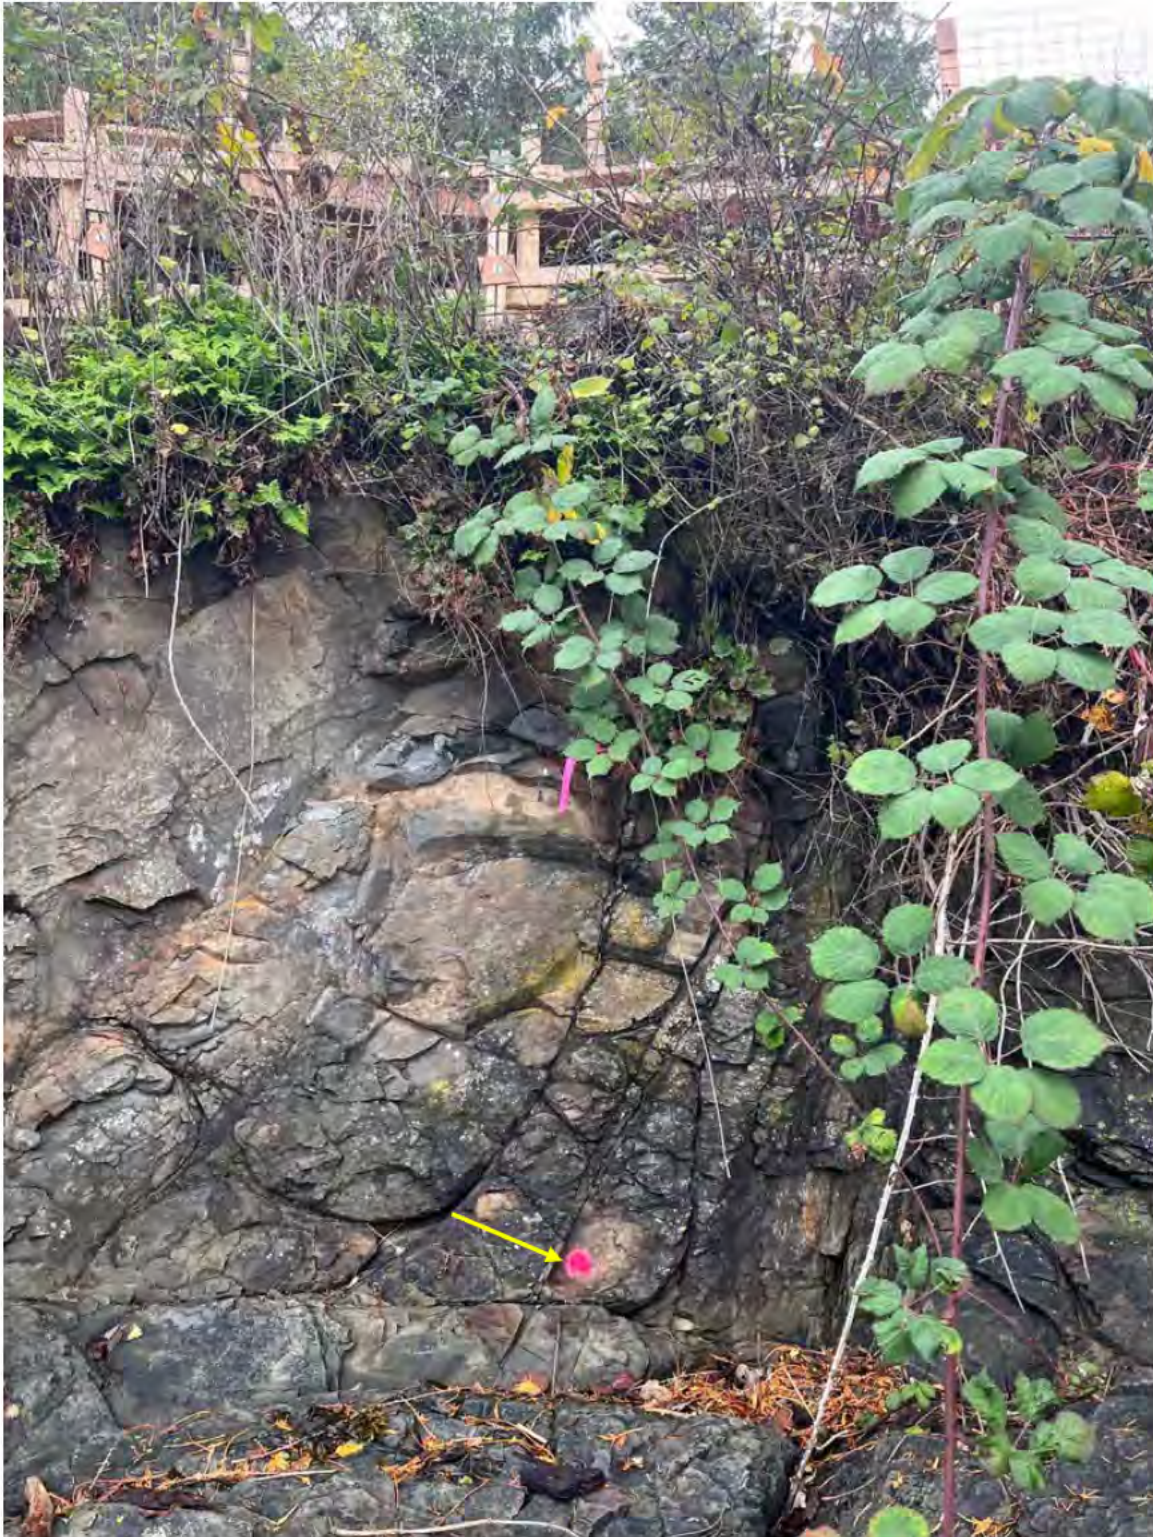
Figure 10. Typical bare bedrock slope with a thin plant covering. The wooden scaffolding will be removed at the end of the remedial works. The area seaward of the scaffolding will be planted with sword ferns. The yellow arrow indicates a red marker indicating the surveyed Present Natural Boundary (Figure 21).

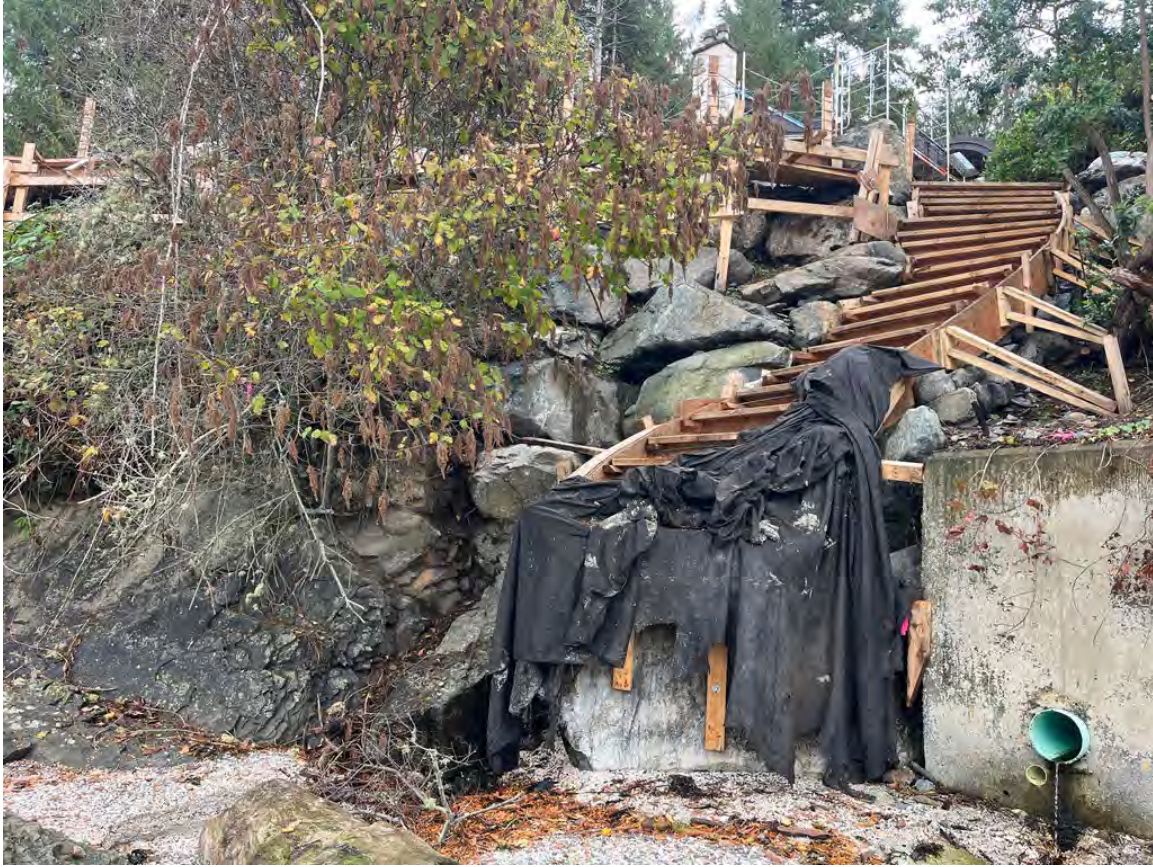
Figure 11. Shoreline stair access to the beach. The lower end of the removable, hinged wooden stairs will not have any permanent structure on the beach below the Present Natural Boundary (Figure 21; see Landscape Plans).

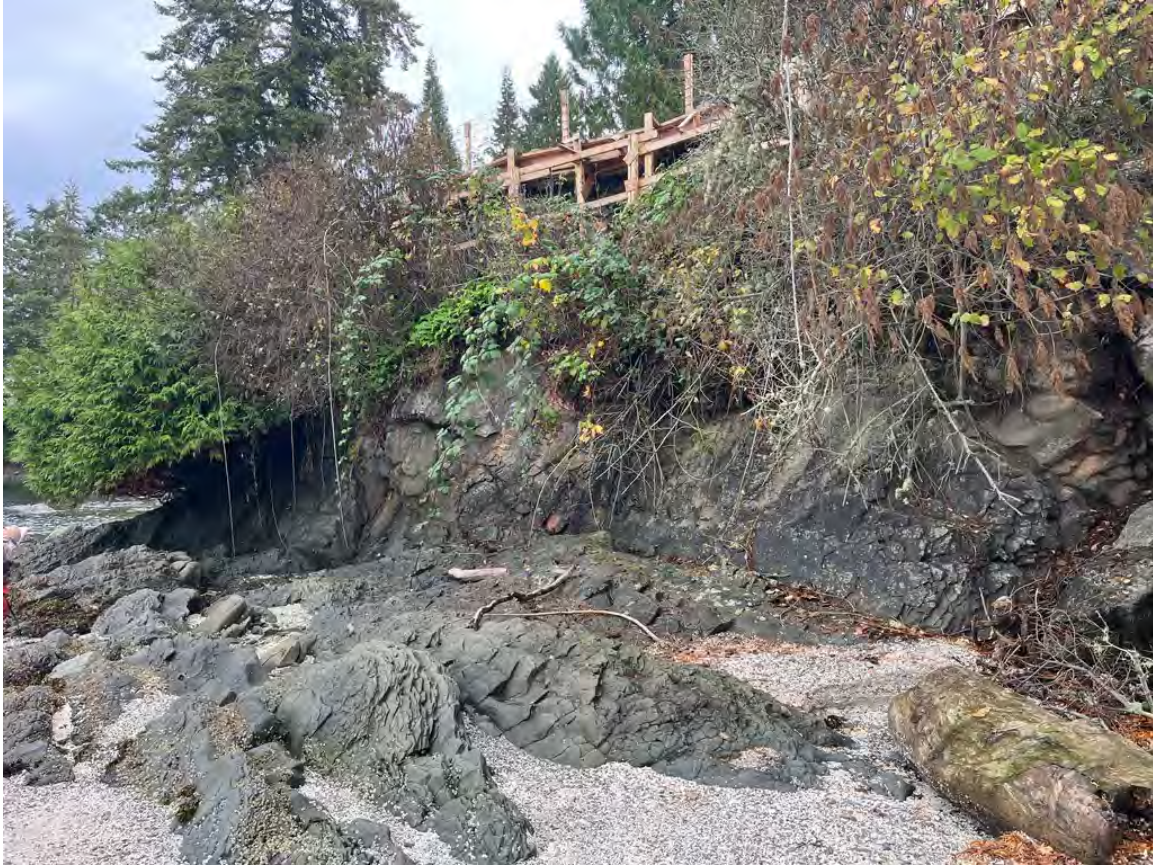
Figure 12. Looking east across the upper intertidal bedrock slope and beach shoreline. The proposed fence and stairs lie beyond the shoreline and have been designed to meet the DPA1 Guideline to “Protect and enhance ecological integrity of marine .... using best practice nature-based solutions to reduce shoreline erosion, and enhance biodiversity, native plant species and wildlife habitat.” No development is proposed below the top-of-bank or on the shoreline.

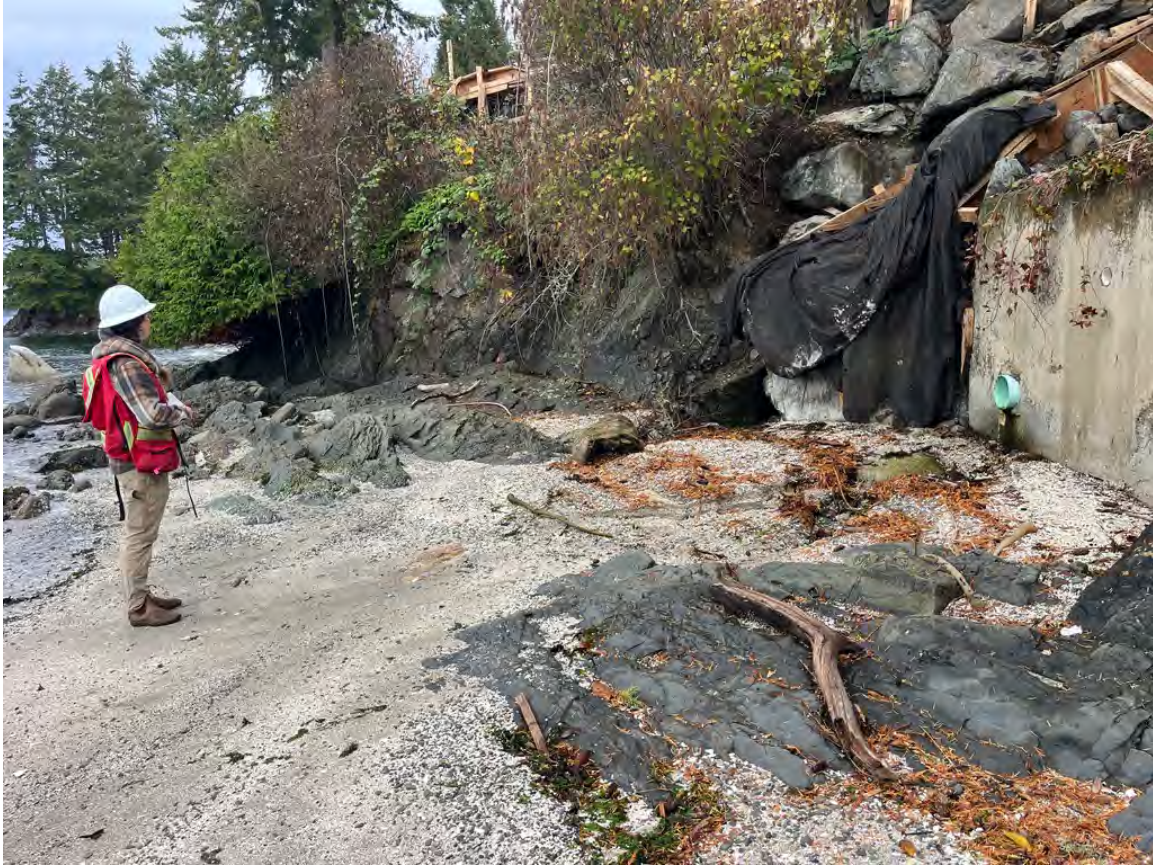
Figure 13. The western property boundary aligns with the concrete retaining wall on the adjacent property. Note the sandy beach sediments providing a thin, unstable cover on the bedrock shelves.

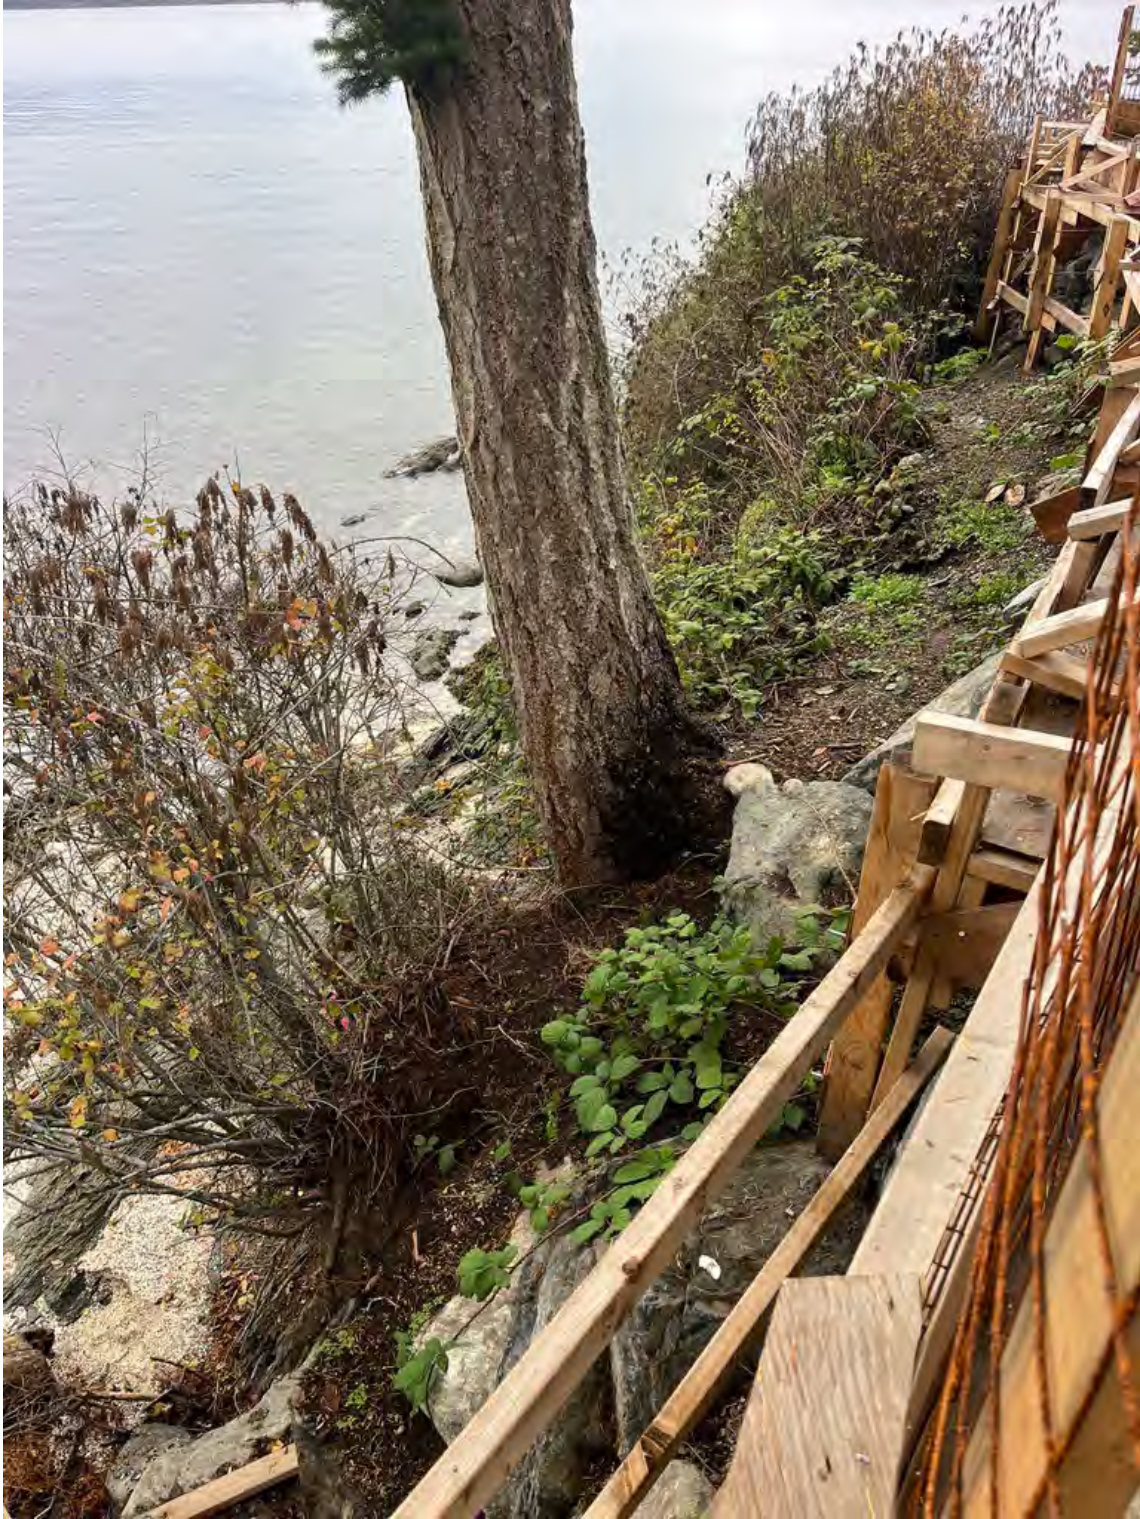
Figure 14. Looking down slope at the Douglas-fir and the top-of-bank soils. The area seaward of the scaffolding will be planted with a dense population of sword fern (see Landscape Plan), in concert with the DPA1 Guideline of supporting nature-based solutions, *i.e.*, the landscape planting enhances the native food-web found in this shoreline habitat.

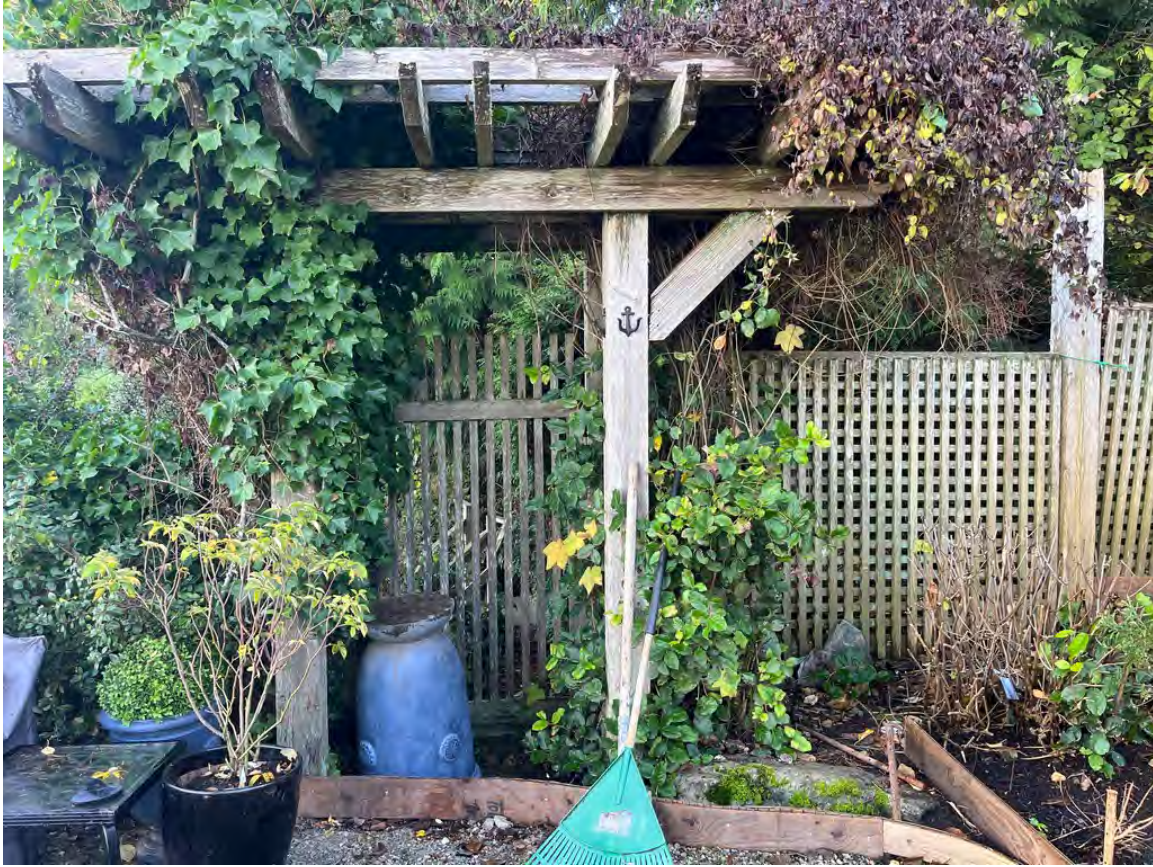
Figure 15. Looking east to the gate in the eastern property fence. The gate provides access to the municipal trail, the latter a public access to the shoreline. The gate and fence will be replaced as they have reached the end of their structural lifespan.

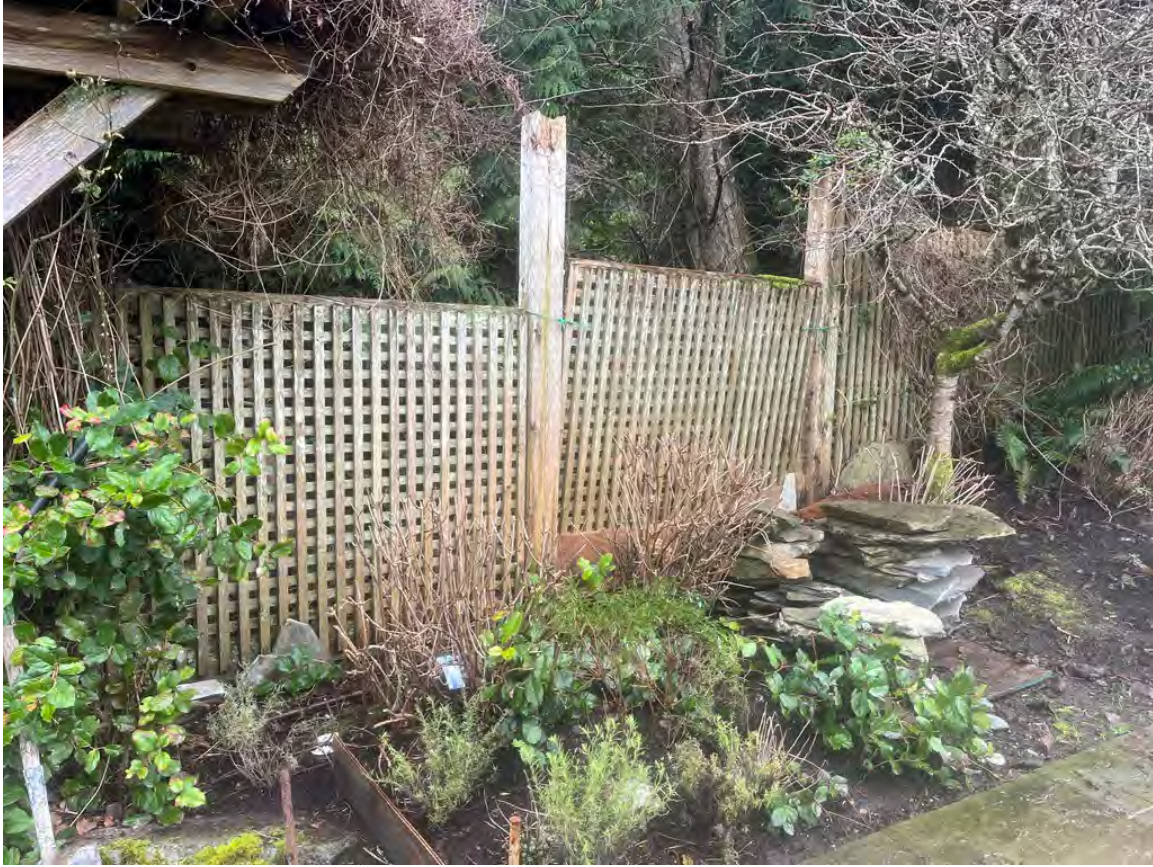
Figure 16. The eastern fence will be replaced as it has reached the end of its structural lifespan.

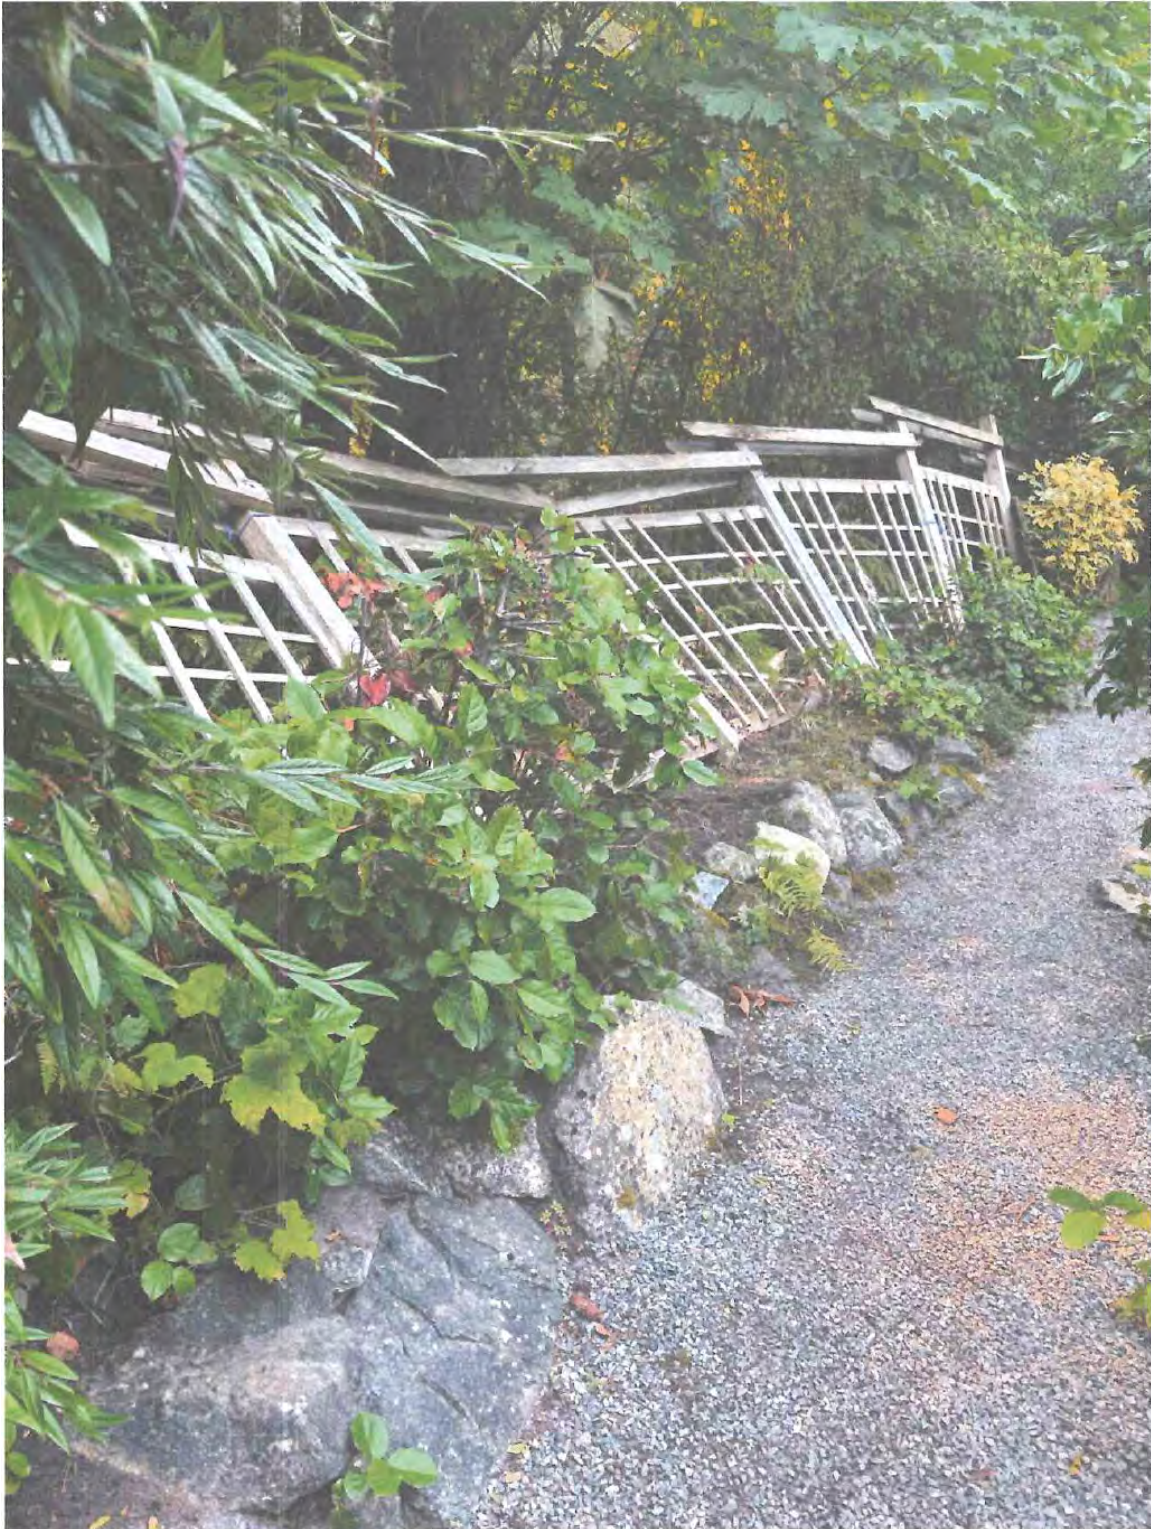
Figure 17. The eastern fence will be replaced as it has reached the end of its structural lifespan.

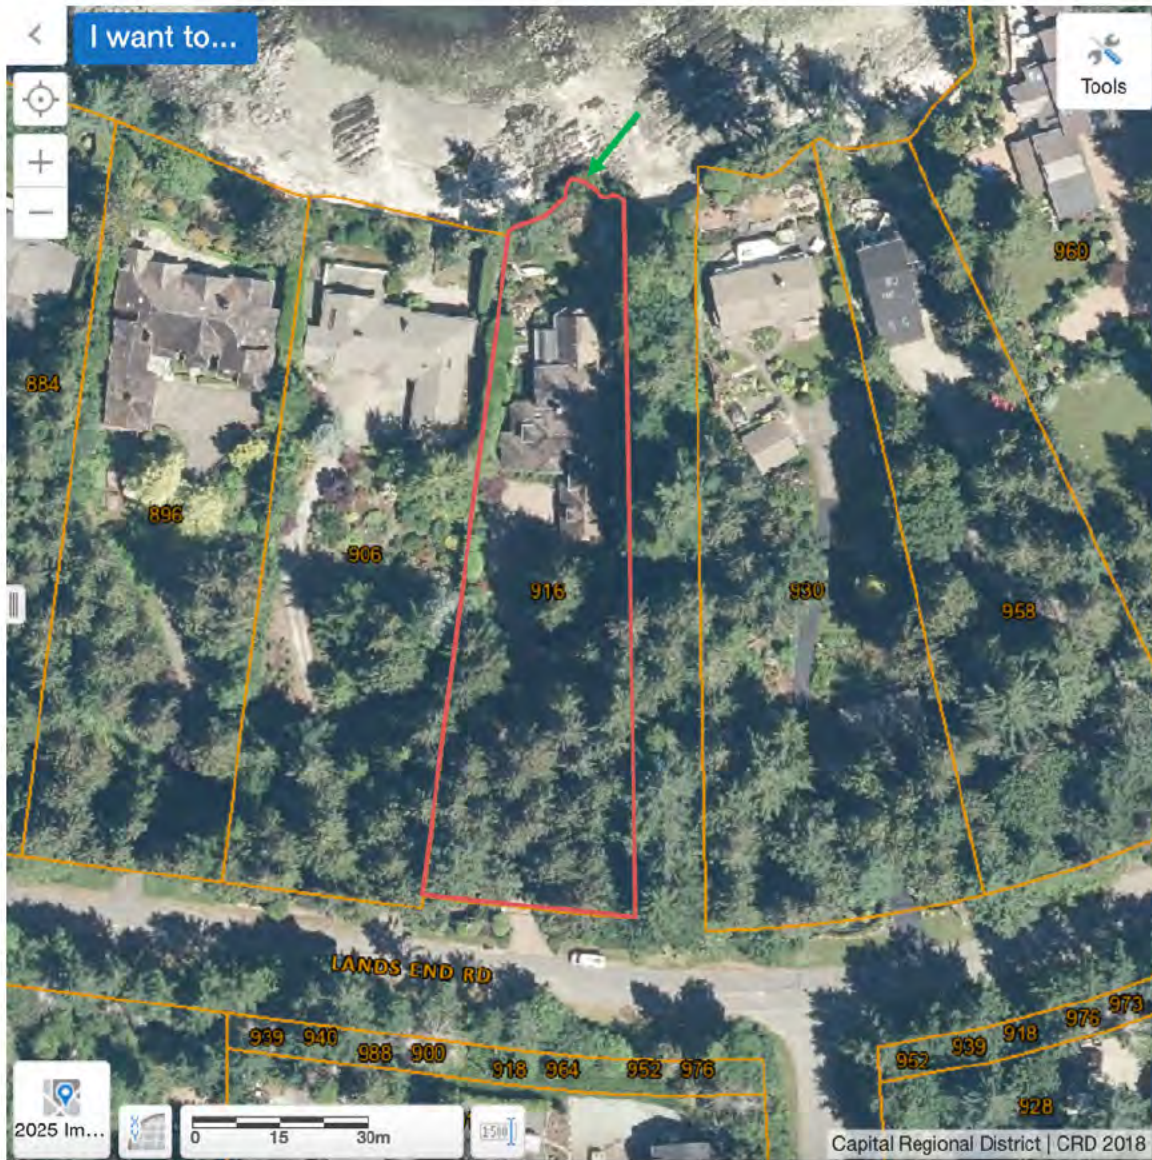
Figure 19. Aerial view of the subject property (red outline) showing the historical disturbance on the landscape lying between the residential dwelling and the shoreline top-of-bank (compare with Figure 20). The green arrow indicates the location of the western red cedar tree (Figure 8).

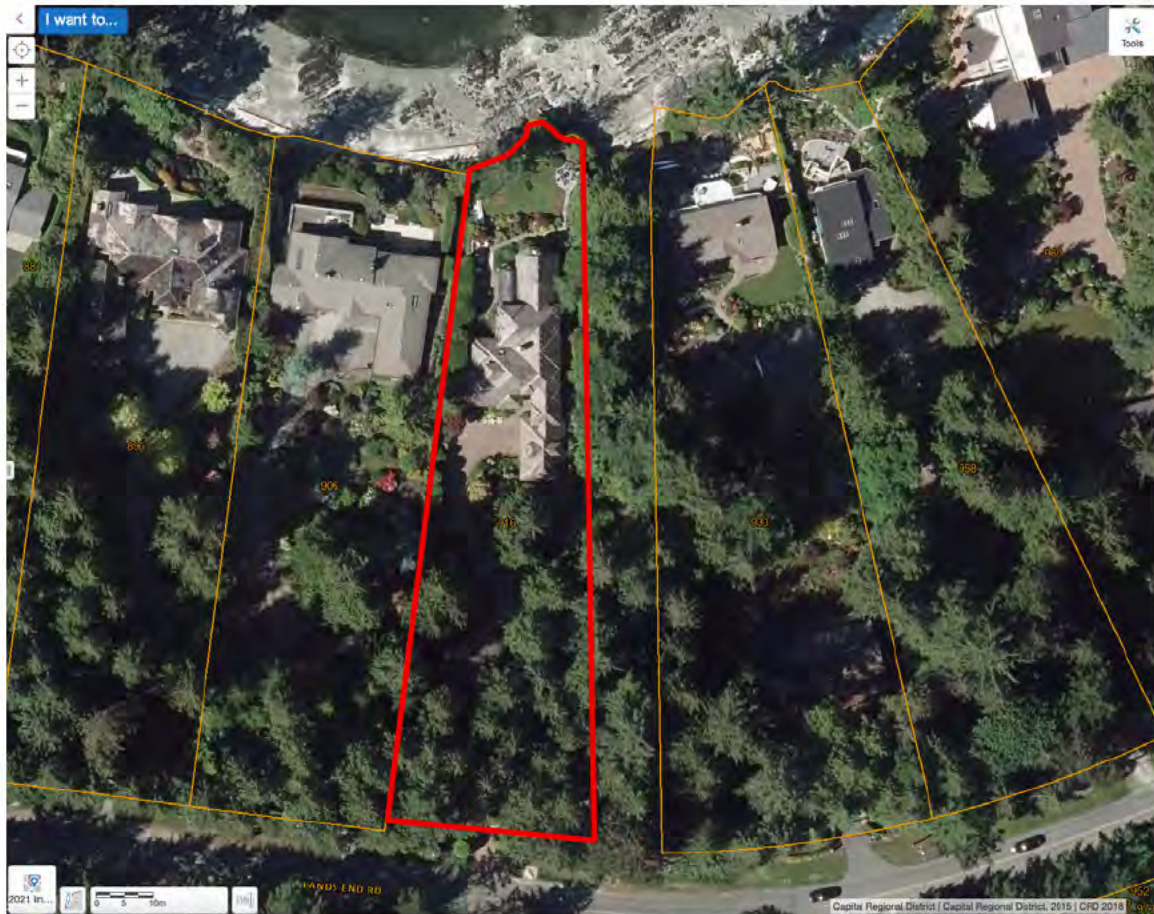
Figure 20. Aerial image of property (red line; 2021 CRD NAA) showing the treed southern half the developed northern half, and the bedrock marine intertidal Zone. Note the grassed marine 15 metre setback area, pathways, and patio area at the northeast corner of the property. The narrow parcel lying to the east is a municipal, public shoreline access trail to the beach (Figure 2).

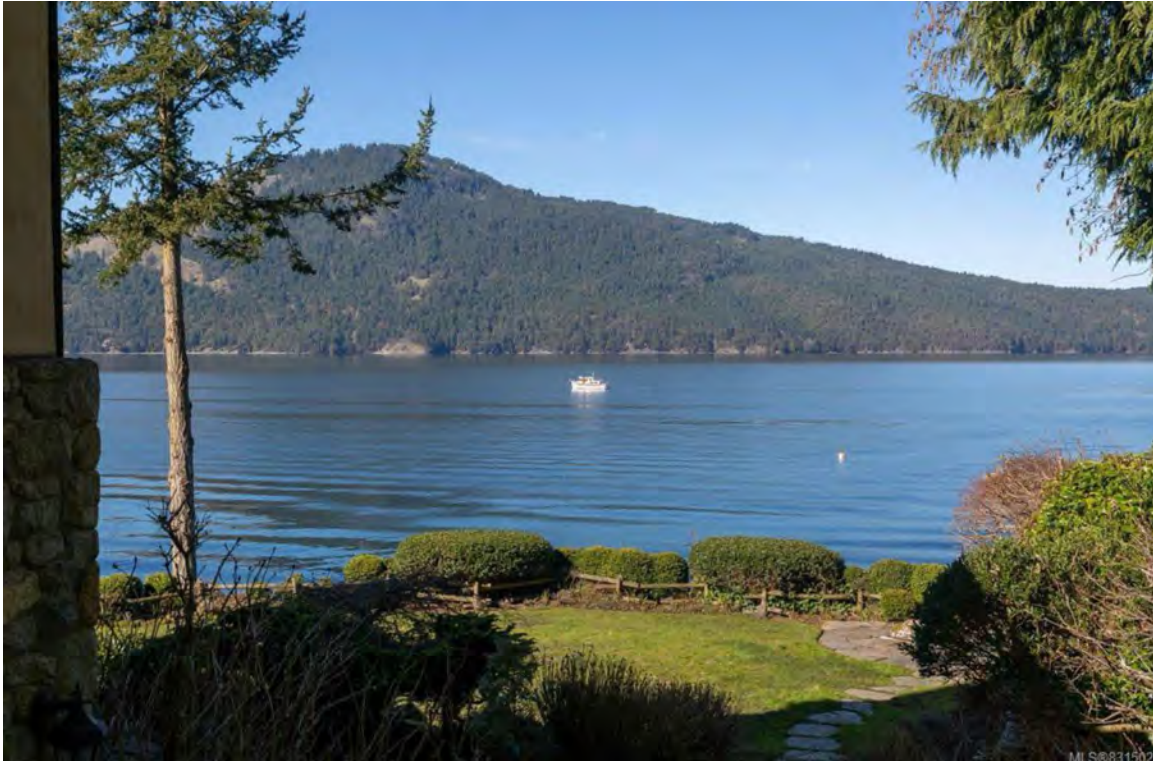
Figure 22. Scenic viewscape looking north across the northern end of the property, across Satellite Channel, toward Salt Spring Island. Note the aging wooden fence along the edge of the lawn and the flagstone pathways. The perimeter landscape vegetation, at the top-of-bank, consists of ornamental non-native plants. Photograph date?

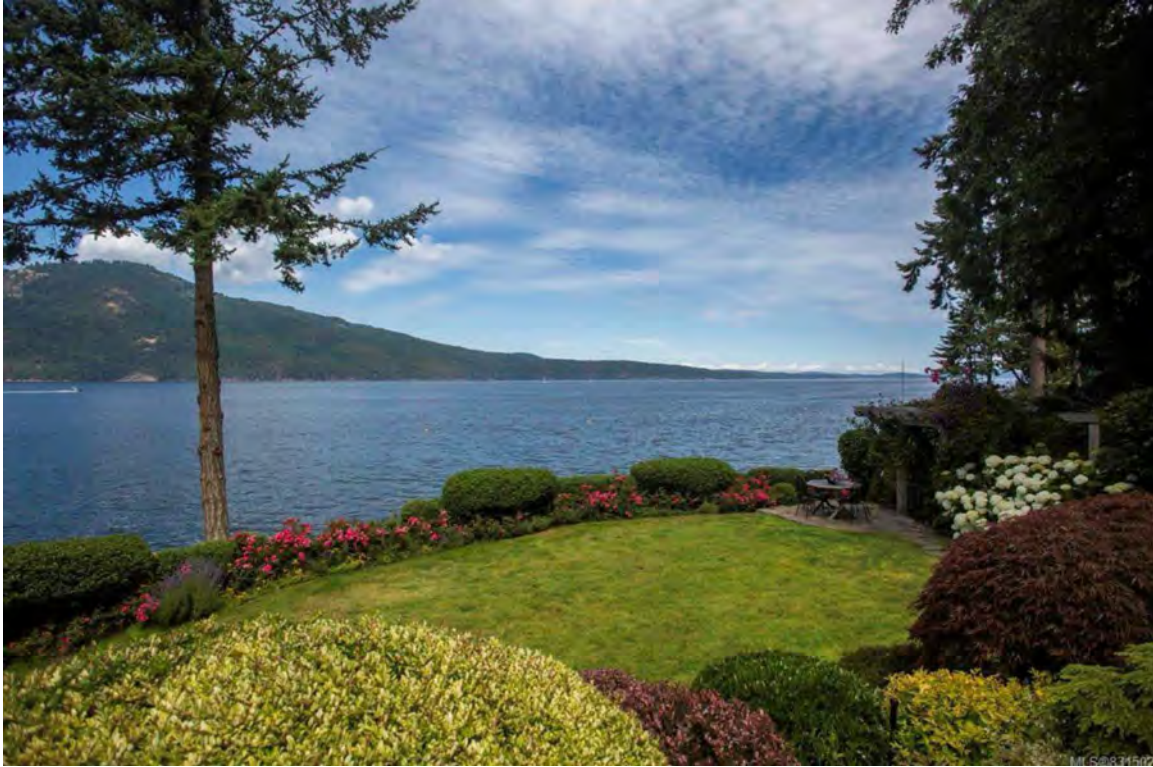
Figure 23.. Looking northeast across the lawn to the northeast patio and the adjacent, gated access to the beach. The aging wood fence lies within the hedge row (image is pre-2019; pre-current owners).
