# Development Application

## District of North Saanich

Civic Address 916 LANDS END ROAD PID 032-551-916

This technical addendum accompanies the architectural and landscape drawings submitted under the Development Permit application. The purpose of this document is to summarize the ecological function, shoreline protection measures, habitat performance and enhancement, and ecosystem service contributions of the proposed native planting plan within a designated Shoreline Development Permit Area. This project proposes new stairs from an upper terrace leading to the lower lawn terrace and the beach. A replacement fence, replacing a dilapidated wooden fence, will provide a safe, security railing at the top-of-bank, the existing patio will be moved laterally to minimize noise for the neighbour, the replacement planting will enhance the natural, riparian food web and habitat, historical rotting fences along the north, east, and west property borders will be replaced to secure the property for the owner's dogs, and the remedial landscape works will protect the shoreline habitat.

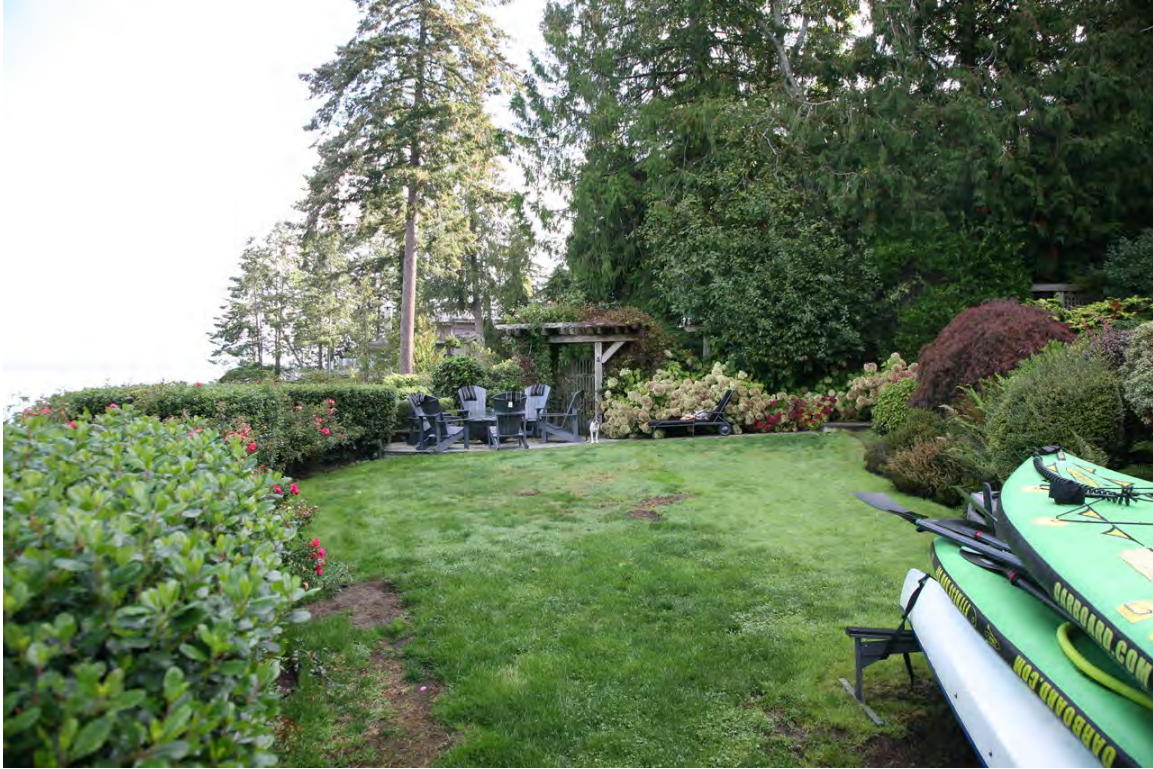
Figure 24. The lawn and patio bordered by the hedge row at the top-of-bank; note the lawn slopes significantly to the north (seaward) (image is circa-2022; taken by current owners).

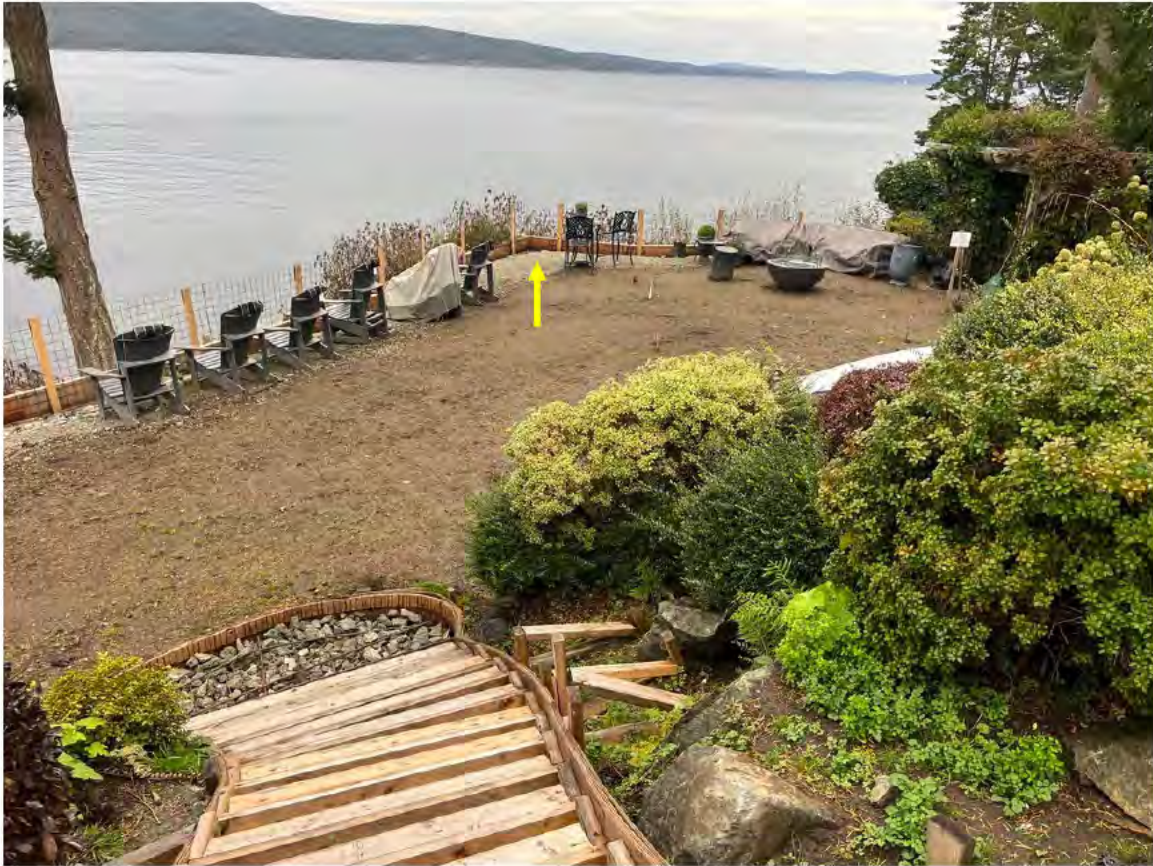
Figure 25. Preliminary landscaping works shown include leveling the lawn, the historical patio will be relocated away from the gate to the point of land (yellow arrow), the stairs linking the upper terrace to the lawn and stairs to the beach, the lawn edge on which the armoured glass fence panels will be installed (temporary mesh security fence), and the Douglas-fir tree.

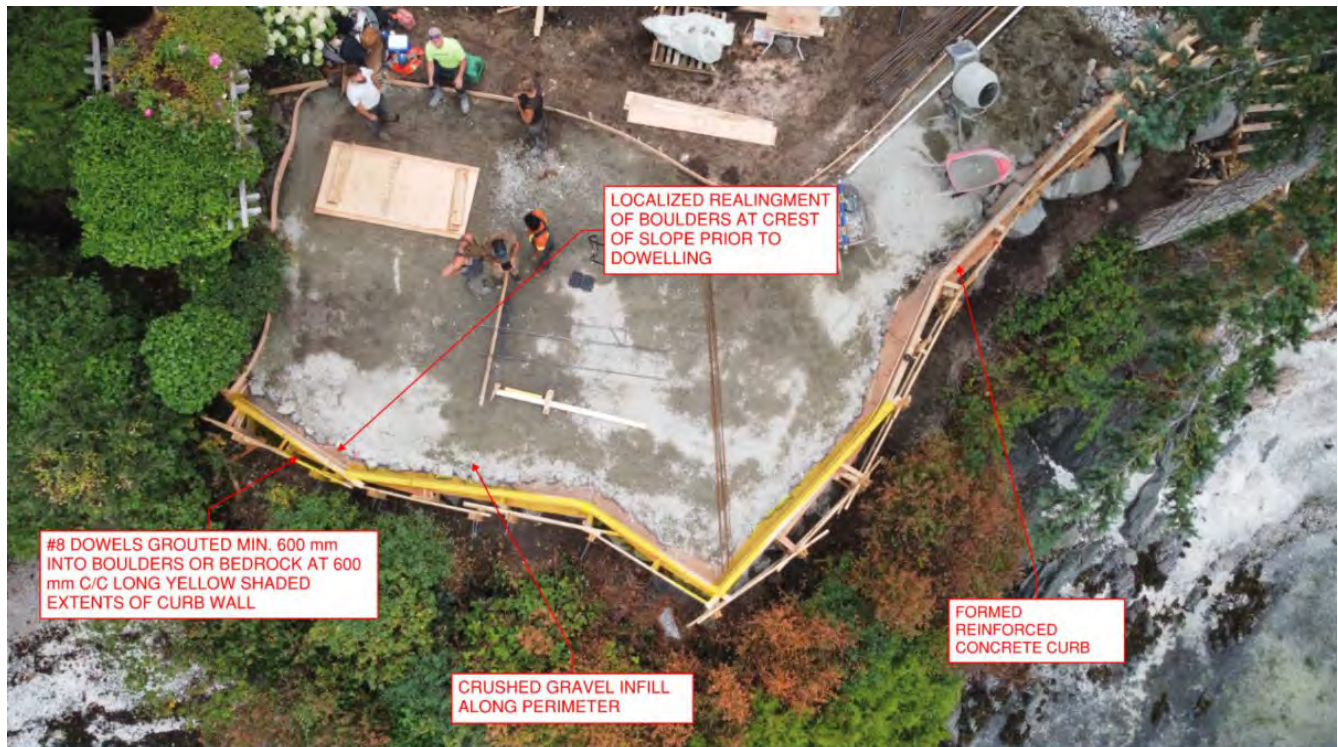
**Plate 2: Drone image illustrating the extent to the curb wall that will define the top of bank along the existing bedrock and stacked boulders. The staircase construction is not shown on Plate 2.**

The area where the proposed improvements is located at the north end of the site as depicted on Plate 2 and Plate 3.

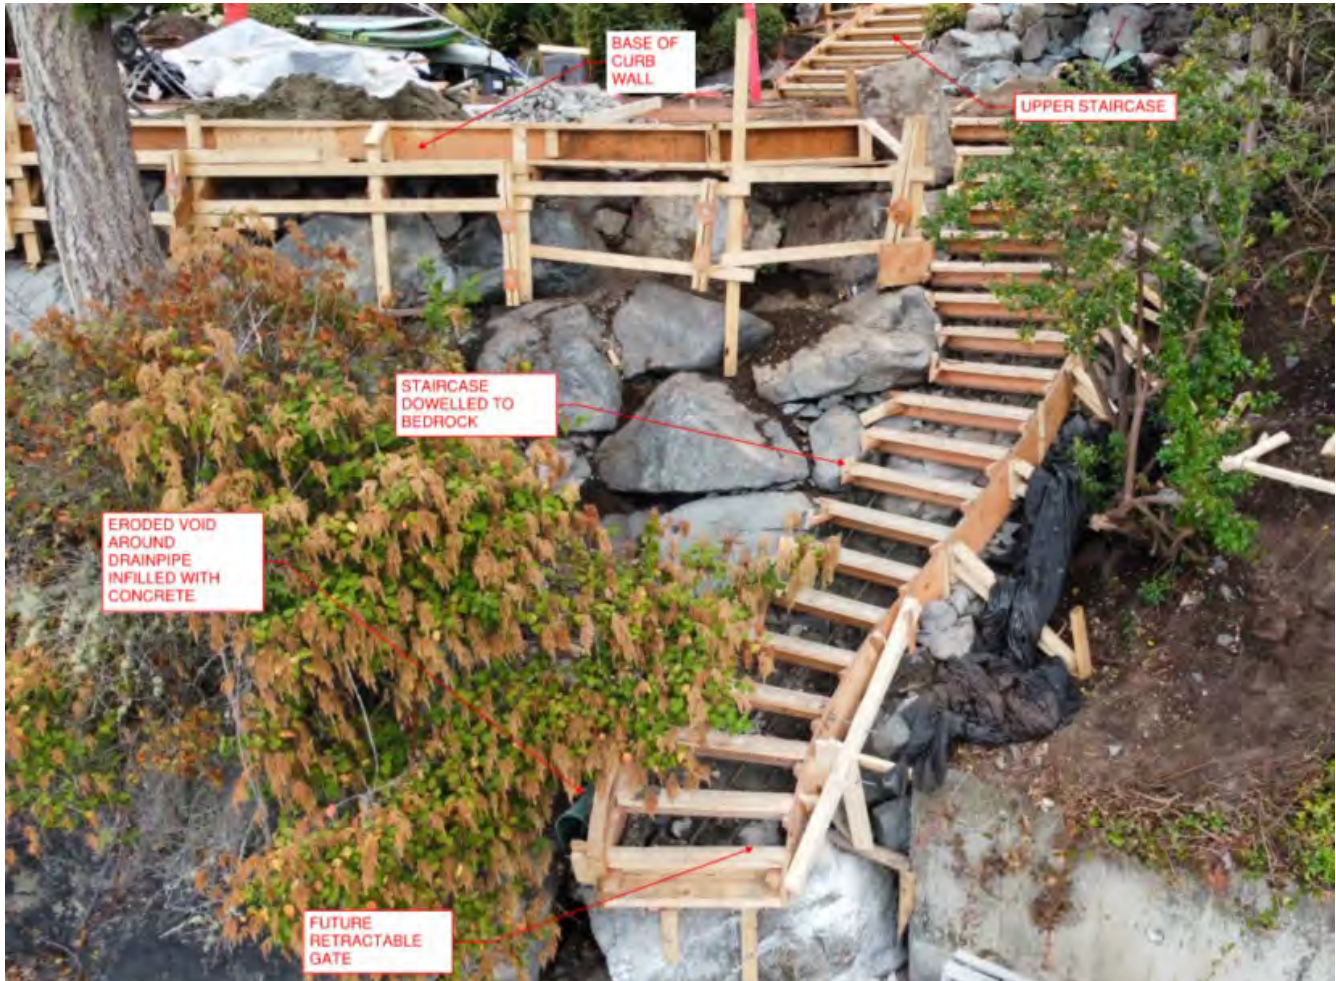
**Plate 3: Looking South showing extents of staircase construction.**

The attached Photographs 1 to 7 also show the works completed to date, which included infilling of voids and levelling the area immediately behind the proposed curb wall. The west, lower staircase, will be secured by way of dowelling it into the secured boulders and cast into the subgrade, at the alignment shown on Plate 3.

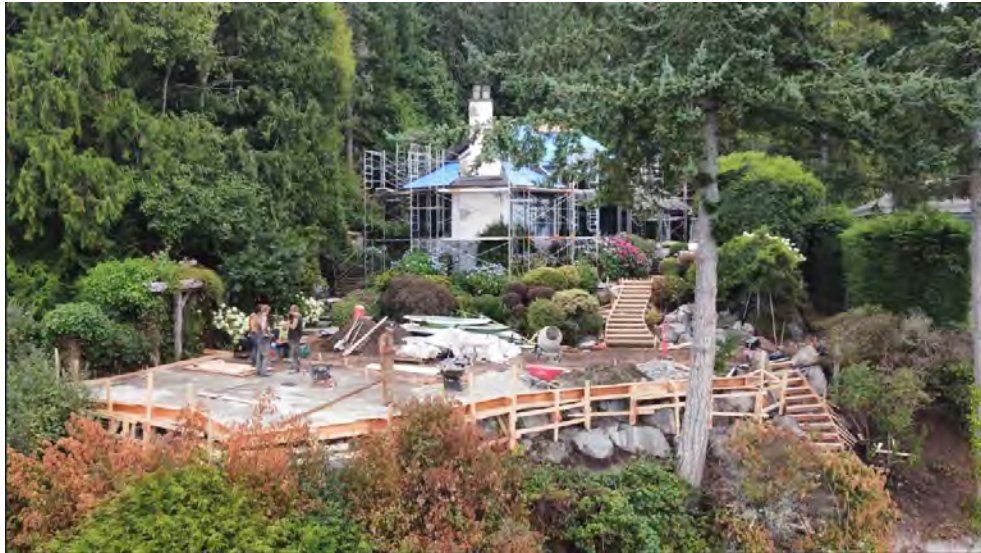
**Photo 2**

Existing stacked boulder wall inclined at about 1 Horizontal to 1 vertical.

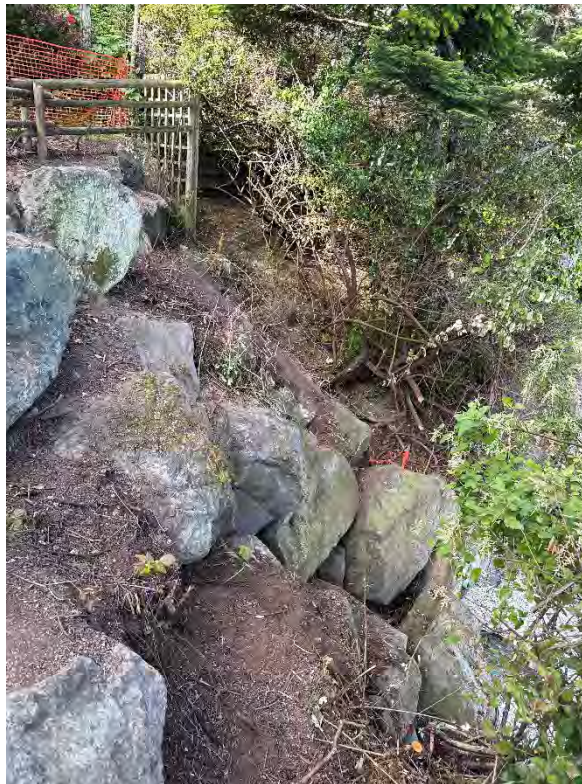
**Photo 3**

Compaction of fill to level area under the proposed curb wall that will be doweled to bedrock.

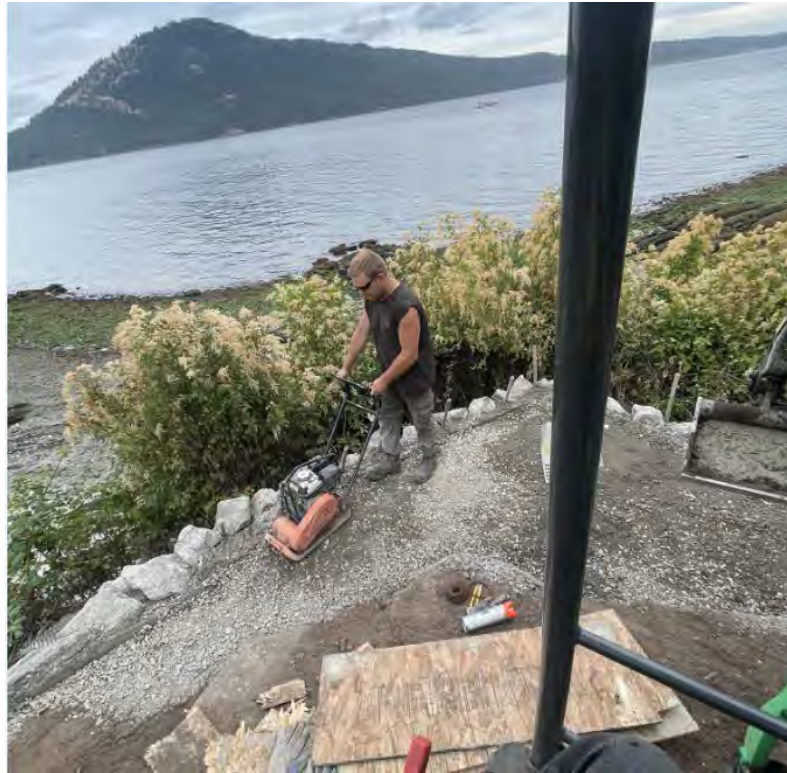
**Photo 4**

Formed curb wall at time of work stoppage.

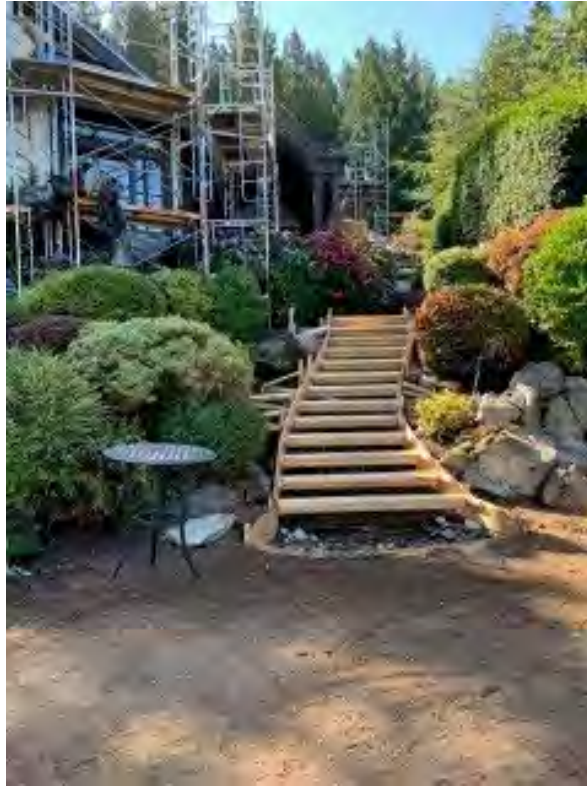
**Photo 6**

Exposed  
drainpipe that  
was secured in  
place by  
concrete as  
part of the  
work  
completed to  
date.

No evidence of bedrock undermining by wave action was noted. However, the Contractor and Owner noted that the material around a PVC drainpipe was eroded away and filled the void with concrete for long-term protection (Photos 6 and 7) prior to GeoWest being engaged.

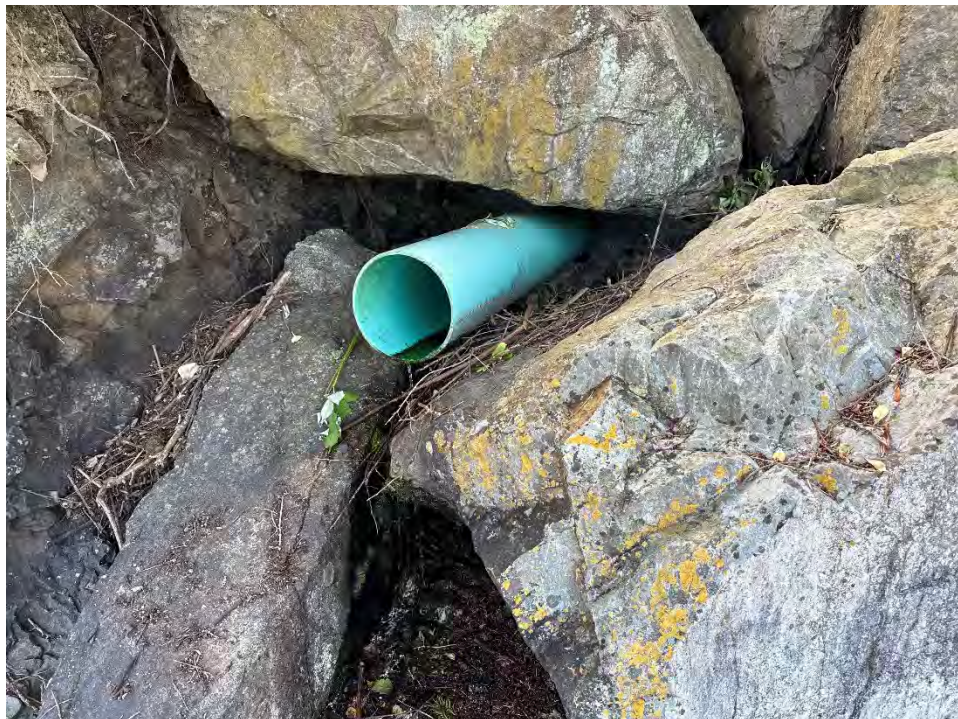
**Photo 7**

Concrete poured around drainpipe at base of boulder slope to protect it from future collapse.
