# Development Application

**Environmental Impact Assessment**  
**687 Ardmore Road – District of North Saanich, BC**

**Re: Geotechnical Assessment of Proposed Foreshore Erosion Protection  
Located at 687 Ardmore Drive, North Saanich, BC**

**MORTARED ROCK RETAINING WALLS**  
687 ARDMORE DRIVE, N. SAANICH

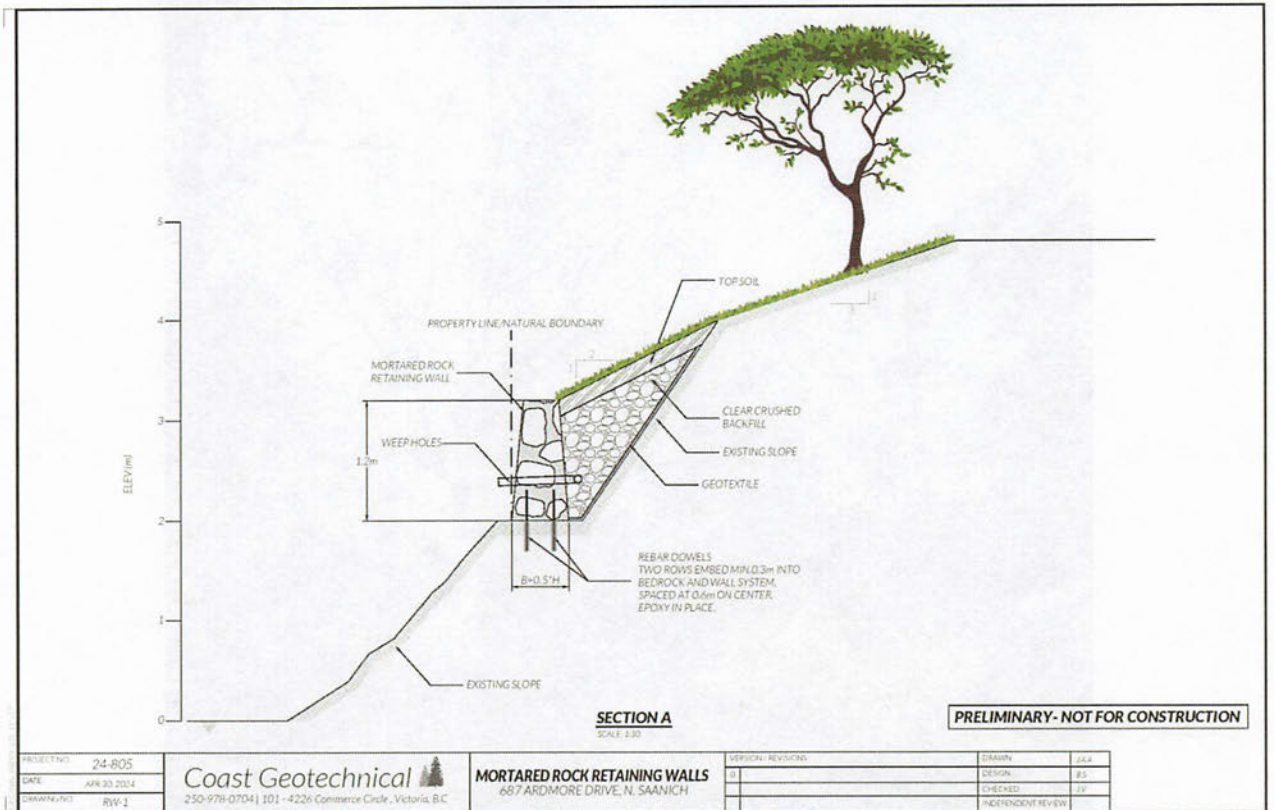
**Cascadia Biological Services**  
**Attachment IV – Overview of the Proposed Retaining Wall**

Note: All work proposed are above the marine High-Water Mark

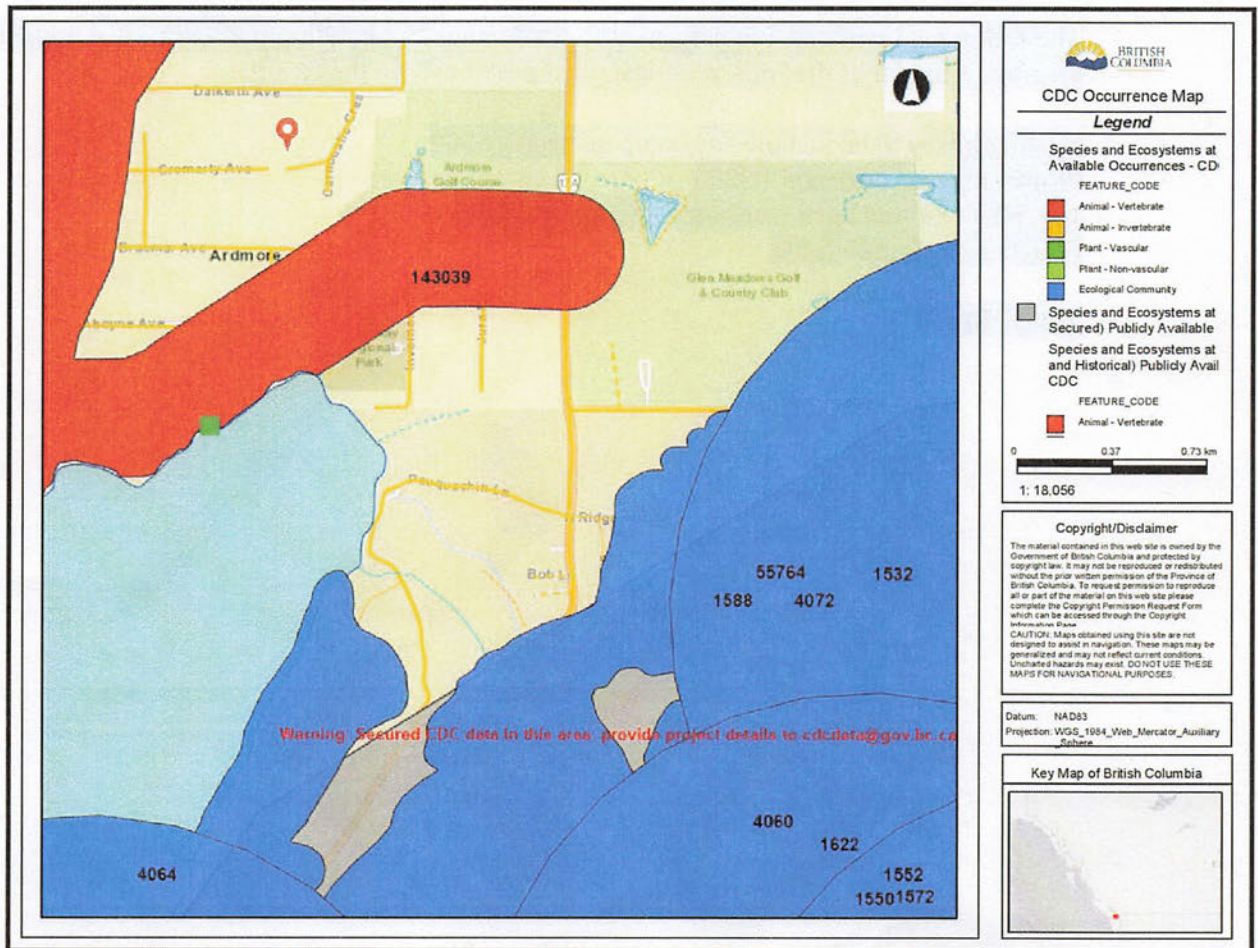
**Cascadia Biological Services**  
 Attachment V – Overview BC CDC Map

Note: Map shows potential for the wandering salamander in and around the Ardmore Road area. No amphibians were noted during our assessment. Subject property identified as green square above
