# DRAINAGE MASTER PLAN

January 2023

District of North Saanich

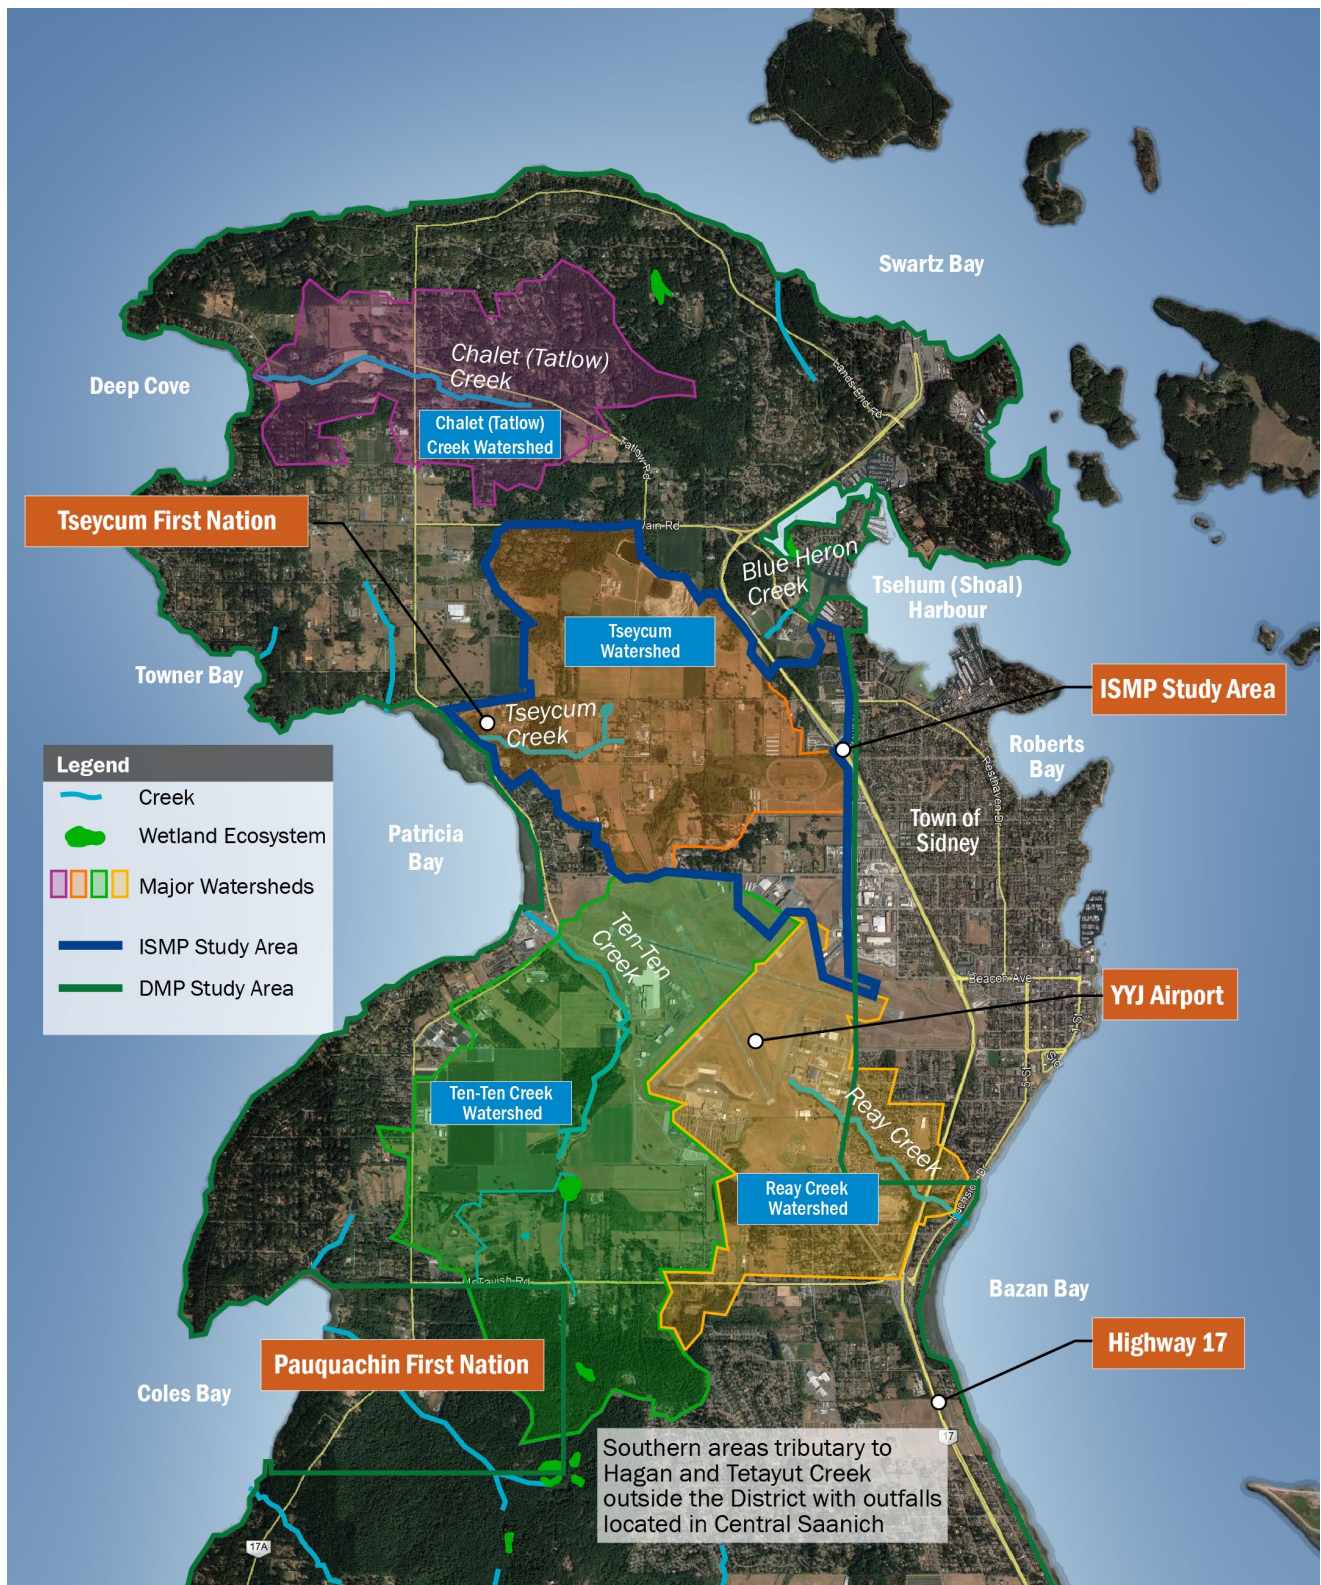
FIGURE 1 - OVERVIEW MAP

The study areas of the Drainage Master Plan (DMP) and the Integrated Stormwater Management Plan (ISMP) are shown in **Figure 1**, which also shows the major watersheds and creeks within the District.

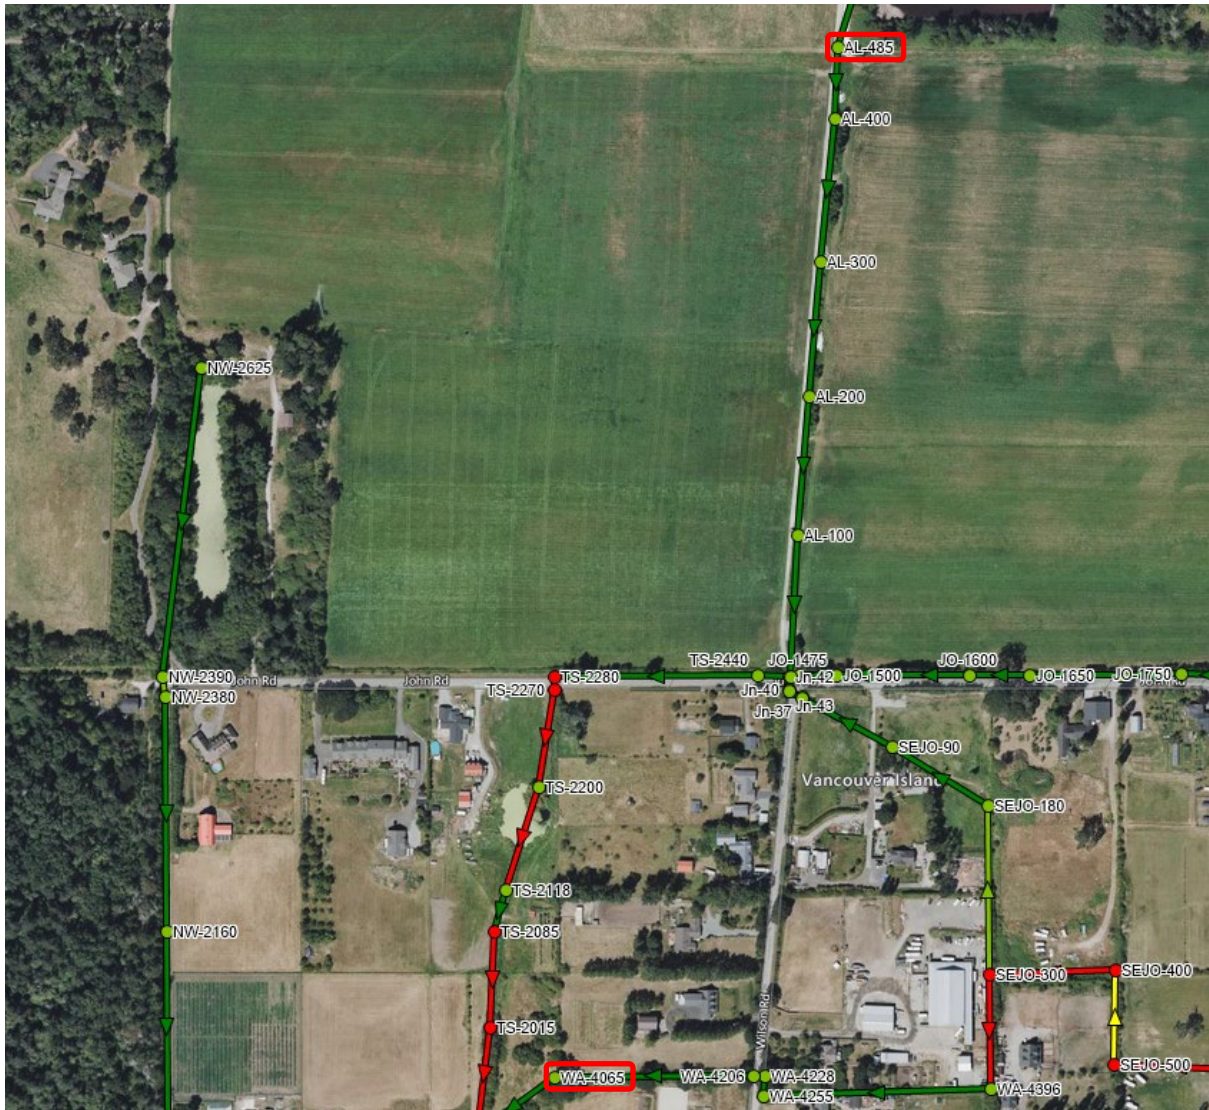
FIGURE 9 - LOCATION OF NODE WA-4065 AND AL-485 IN TSEYCUM CREEK

Two representative locations were selected to assess the drainage criteria for agricultural areas. As the flow level needs to be 1.2 m lower than field elevation only major drainage ditches could be considered, as most drainage ditches in the District are only about 1.0 metre deep. It was decided to assess junction node ‘WA-4065’ and ‘AL-485’ both located within the Tseycum Creek watershed. Their locations are shown in **Figure 9** below.

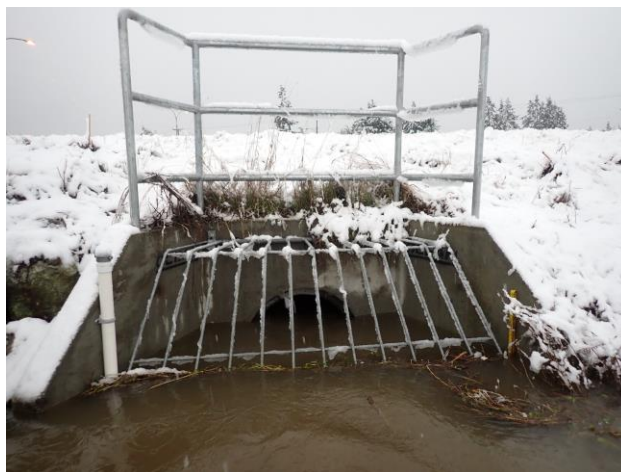
**Photo 1: Inlet @ 12:30 pm**  
Recorded Water Level – 0.66m (staff gauge)

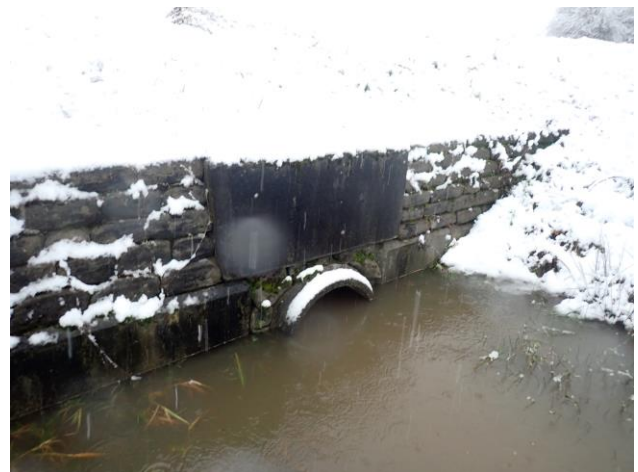
**Photo 2: Outlet @ 12:35 pm**  
Recorded Water Level – 0.53m (above invert)

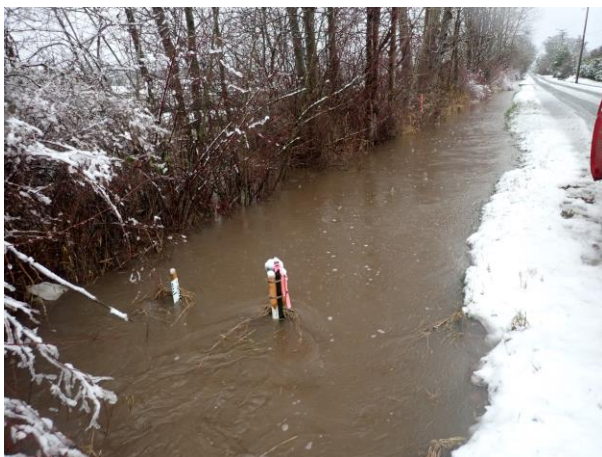
**Photo 3: Flow Meter @ 1:30 pm**  
Recorded Water Level – 0.85m (staff gauge)

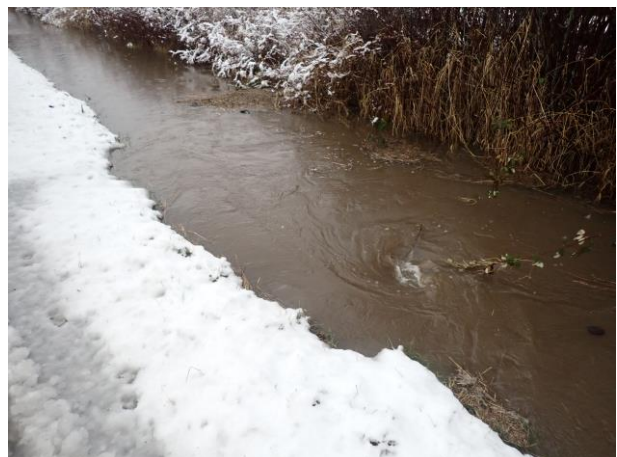
**Photo 4: Inlet to Twin Culvert @ 1:30 pm**  
Recorded Water Level – Fully submerged

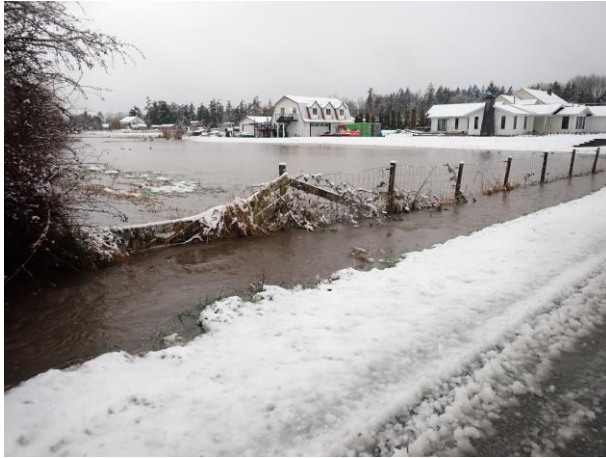
**Photo 3: Outlet from Twin Culvert @ 1:30 pm**  
**Recorded Water Level – Fully submerged**

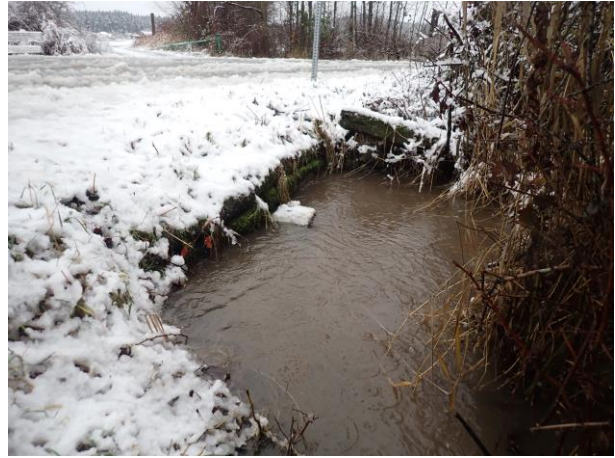
**Photo 4: Inlet to Culvert @ 1:36 pm**  
**Recorded Water Level – Inlet fully submerged**

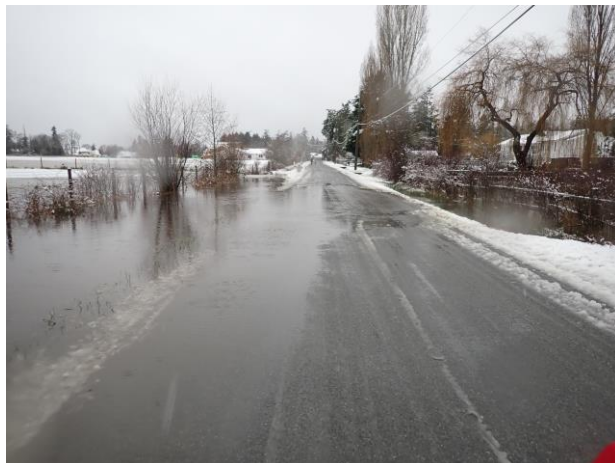
**Photo 5: Munro Road @ 1:40 pm**  
**Recorded Water Level – Flow over Munro Road**

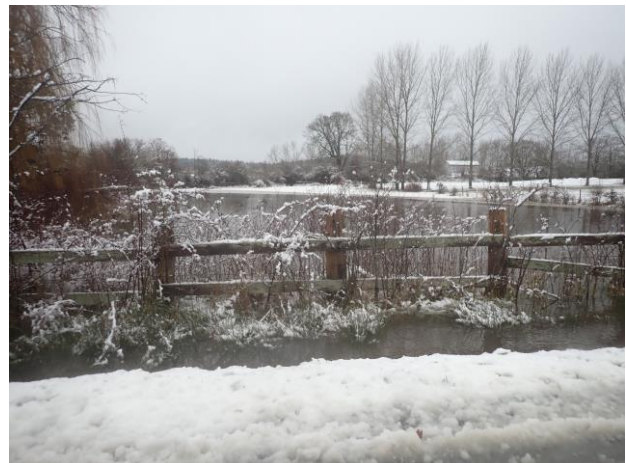
**Photo 6: Field @ 1:47 pm**  
**Recorded Water Level – Flooded field**

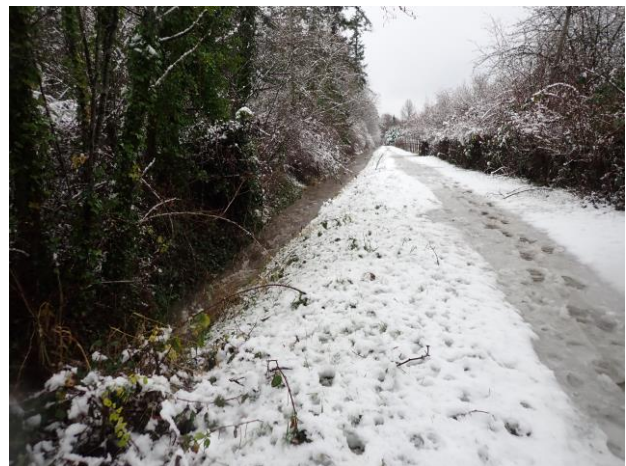
**Photo 8: North Tributary @ 1:44 pm**  
Recorded Water Level – N/A

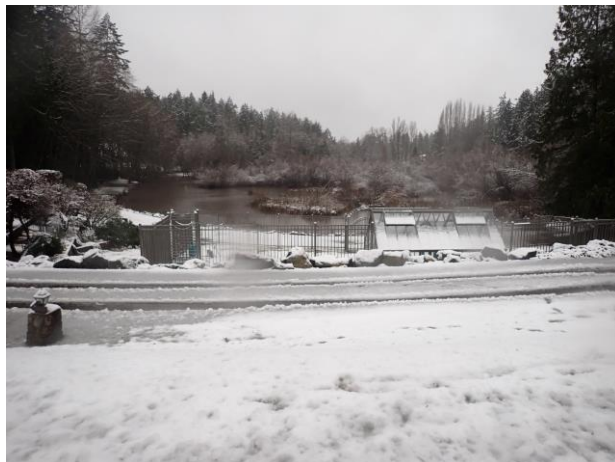
**Photo 9: Pond @ 1:59 pm**  
**Recorded Water Level – Flooding around pond**

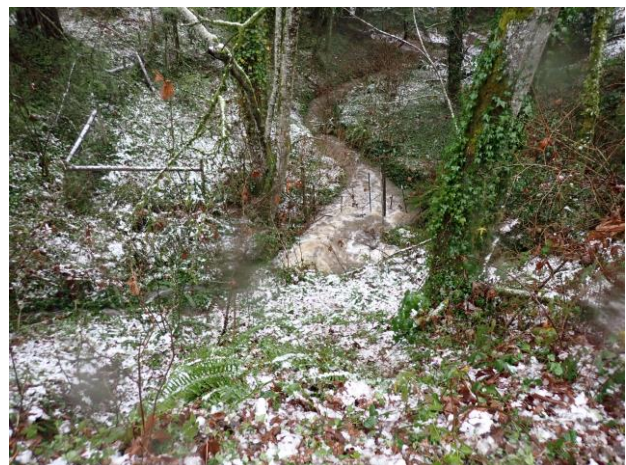
**Photo 2: Culvert Outlet @ 2:05 pm**  
Recorded Water Level – N/A

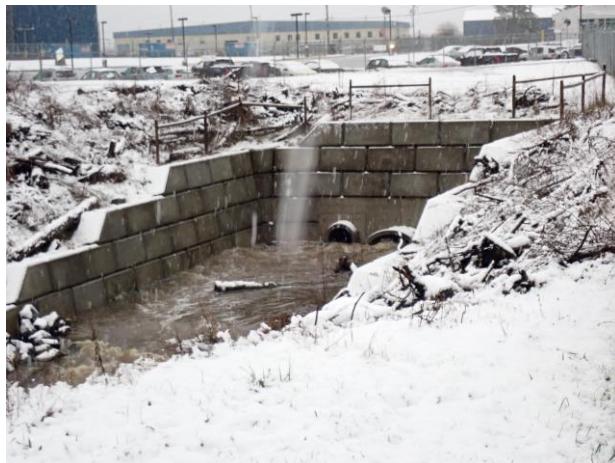
**Photo 11: Culvert Outlets @ 2:14 pm**  
Recorded Water Level – N/A

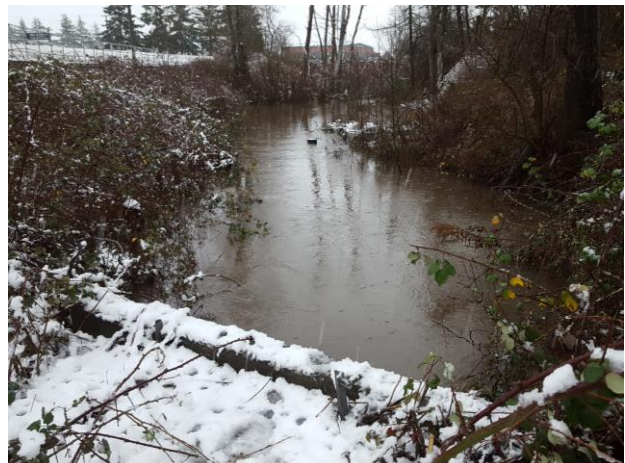
**Photo 2: Culvert Inlet @ 2:14 pm**  
Recorded Water Level – Surcharged and staff gauged observed just below surface

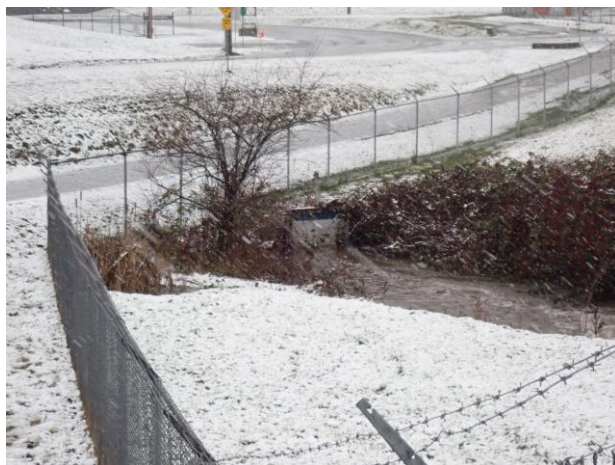
**Photo 12: Culvert Inlets @ 2:21 pm**  
Recorded Water Level – Submerged Inlet

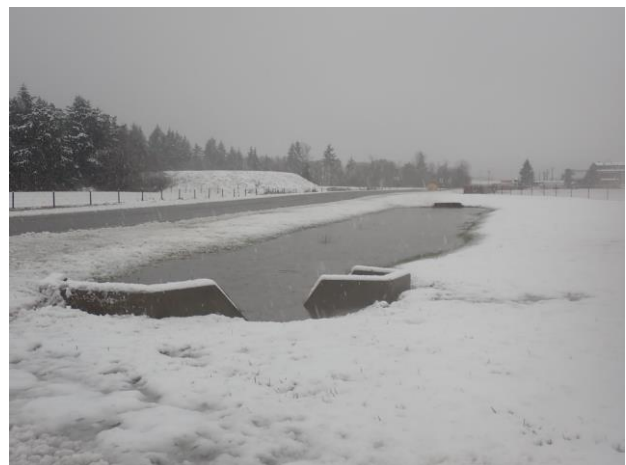
**Photo 2: Culvert Inlet/Outlets @ 2:24 pm**  
Recorded Water Level – Submerged

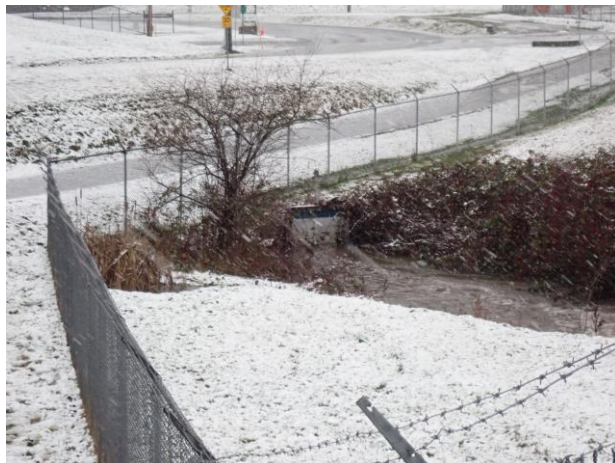
**Photo 13: Culvert Inlets @ 2:28 pm**  
**Recorded Water Level – Submerged inlet**

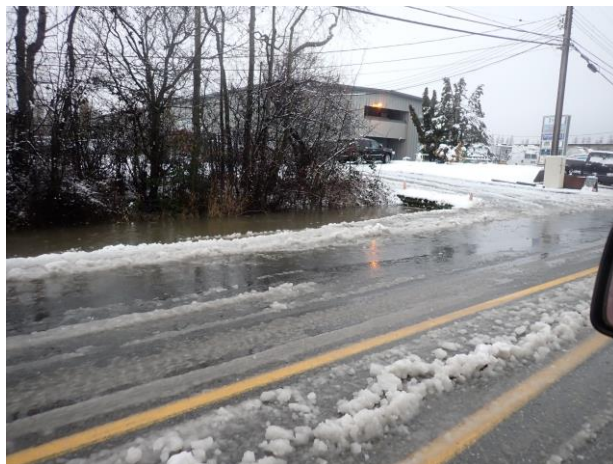
**Photo 14: Culvert Inlet @ 2:34 pm**  
Recorded Water Level – Submerged inlet

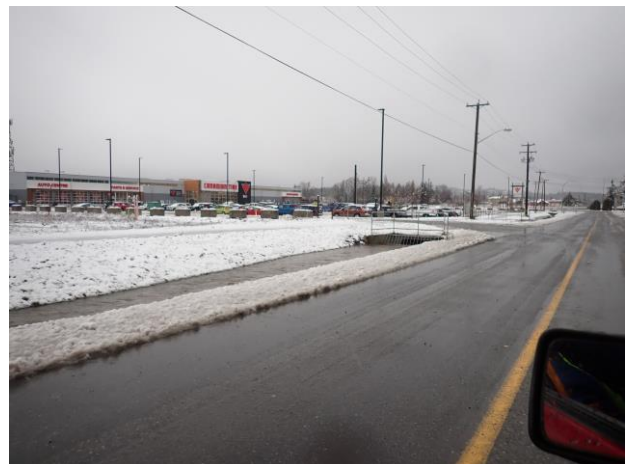
**Photo 2: Culvert Inlet @ 2:35 pm**  
Recorded Water Level – 0.25 m to Obvert (+/-)

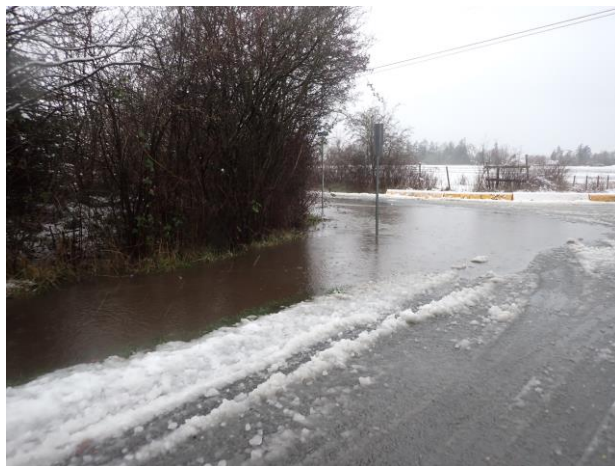
**Photo 15: Munro at Wilson @ 3:07 pm**  
**Recorded Water Level – Road flooded**

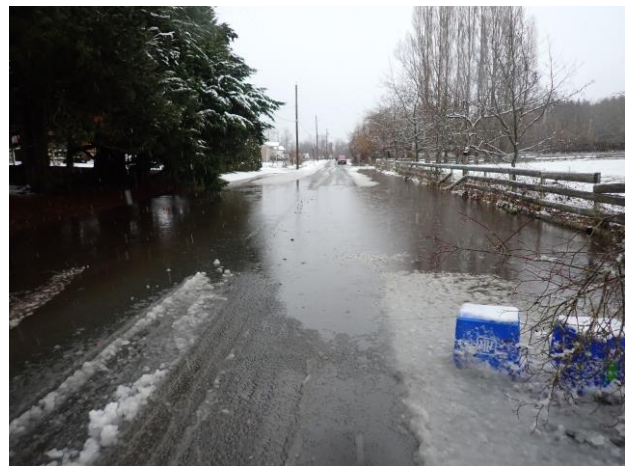
**Photo 2: Munro Road @ 2:58 pm**  
**Recorded Water Level – 0.05 m over road**
